Detachments Detection at the 'Grand Stairway' in the Room 38 of the *Domus Aurea* using the PICUS System

Abstract

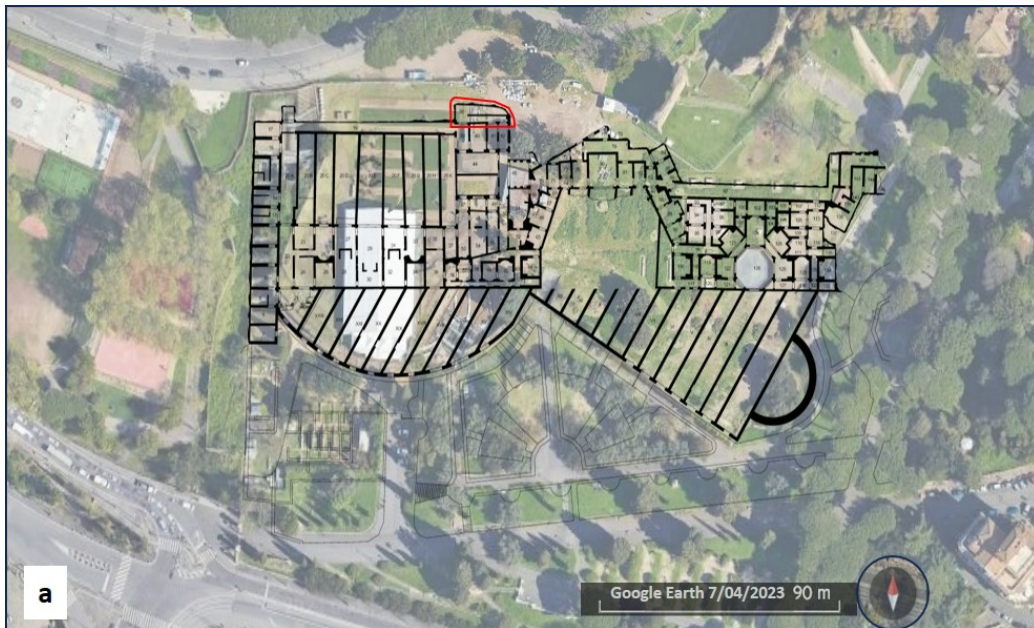
Figure 1: In (a), the currently known plan of the Domus Aurea of the Baths of Trajan and the gardens above. Room 38 at the northern edge of the excavation is highlighted in red. In (b) the schematic elevation drawing of the Stairway 38, north side. Top left: Trajanic arch intersecting the second landing vault. (3).

stitutes the limit of a complex of rooms gravitating around the so-called Nymphaeum of Polyphemus. The north wall of Room 38 separates the architectural setting from the unexplored spaces, currently still buried under the Colle Oppio (1), as visible in figure 1.a.

This space, inserted between pre-existing architectural elements, underwent several transformations over the course of time until, before the final Trajan's burial, it became a monumental and scenic "Grand Stairway" connecting the rooms on the first floor of the complex with the upper garden level. A wall within the center of the hall, resembling the spine of a stadium, constituted a structure such that, using leveled wooden beams, a step-less staircase was formed. From the western end, bordering Room 39, one accessed to the first ramp, from which two more ramps continued to the outer pavilions of the north terrace of the Domus, as visible in the schematic reconstruction drawing in figure 1.b.

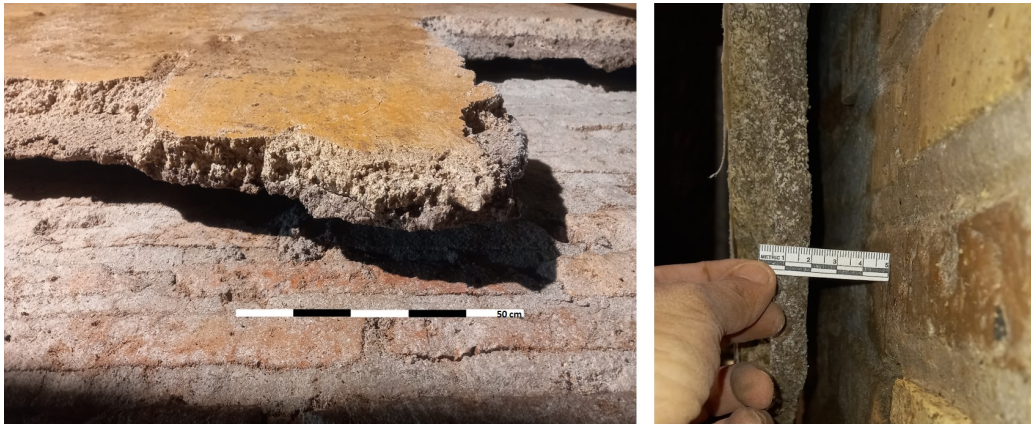
Significant detachment phenomena (7) have occurred because of the leaking, with large portions of the mortar separating from the wall support. In result, the plasters on the south and west sides of the second ramp's floor showed only a few isolated sections of adherence to the wall support. An area of about six square meters of plaster was only held in place along the upper edge by the fiberglass vault itself, resembling large mortar slabs ready to give way by their own weight, as in figure 1. Thanks to the composition of the original mortars, based on pozzolana, plasters have retained their mechanical characteristics, still cohesive and "stiffly elastic". The detachment from the wall support appears to have acted as a protective barrier, isolating the layers and mitigating the degradation effects.

Figure 2: Detached plaster on the south wall

The stabilization intervention for the painted plaster on the south side of the second floor of the ramp adopted a gradual approach. The process began by supporting the lower profile of the plaster layers, ensuring that the hanging slabs remained uncompressed. After several trials, a handcrafted mortar based on natural hydraulic lime and pozzolana, with filling and adhesive characteristics, was prepared. This mortar was used to create a support curb to make the edges of the plaster solid with the wall surface. To ensure water drainage, restorers inserted aluminum tubes with an 18 mm diameter into the fresh mortar to create passage channels crossing the curb. These tubes ascend into the gap between the plaster and the wall for a height of approximately 60 cm. The second step involved filling a portion of the void between the remaining plaster, the still adherent portions, and the curb. Injections of mortar with very low specific weight formulated for consolidation and re-adhesion was performed. During this phase, the tubes in the gap were left on place to ensure that the channels remain open. When the grouting mortar was set, the tubes have been carefully removed, leaving water pathways.

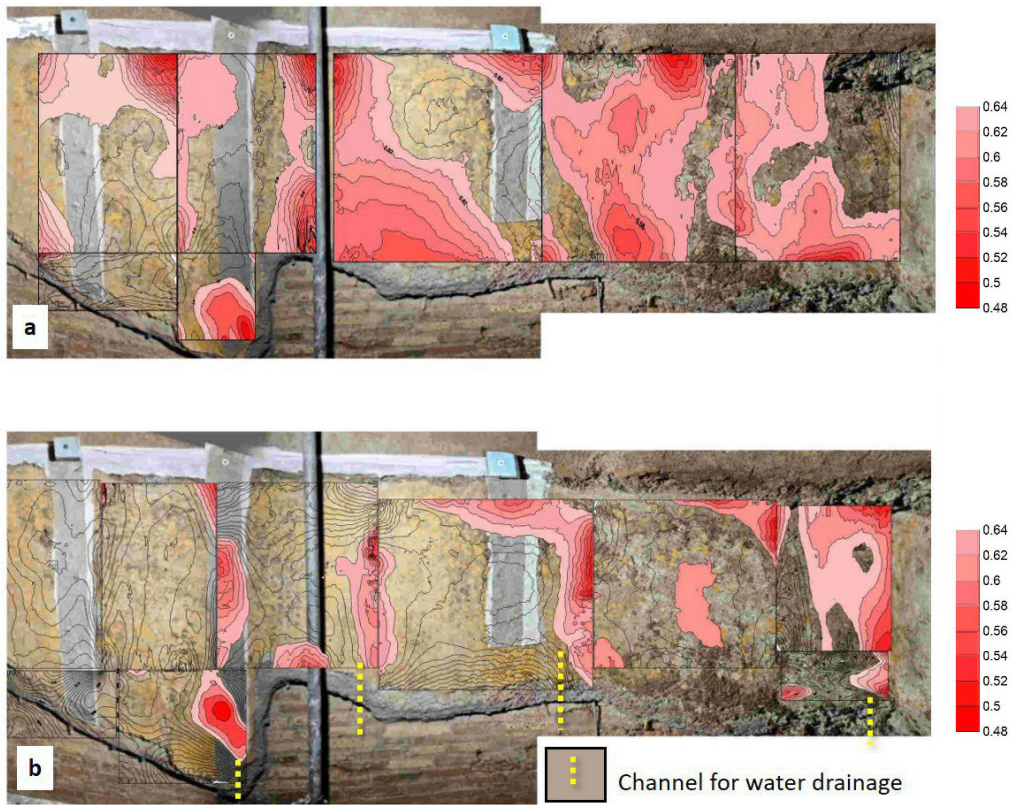
The primary goal was to stabilize the detached plaster and prevent it from losing material or falling, therefore, it was necessary to carefully assess the entity of detachments before intervention. Both methods, auscultation and PICUS scan, were implemented and produced a map representing the defects; in figure 5.a, the map of detachments obtained before the intervention, using the PICUS system. The PICUS System map highlights the most severe issues using a colorimetric scale⁸. This is achieved by setting a threshold of cross-correlation values less than or equal to 0.64, instead of the typical value of 1, to ensure clarity in representation. By setting the maximum cross-correlation value in the representation to a lower threshold (0.64 in this case), the focus is shifted toward highlighting defects that deviate from the reference point (indicating no detachment). This approach avoids displaying all contour levels and emphasizes areas with significant differences, making the defects specific to the object under examination more prominent. The threshold is indicative, tailored to the needs of this case, and informed by the professional experience of the conservators. It can be considered a marker for detachments that require prompt action, while higher cross-correlation values are intentionally omitted from the representation. The comparison between the map obtained through the auscultation method and the PICUS map demonstrates that they can be superimposed, as both provide a qualitative

Figure 5: Maps of detachments obtained: in (a) before the intervention, in (b) after the intervention

distribution of detachments. This alignment is particularly important, as it confirms that the indications traditionally perceived through human auscultation are consistent with those detected by the PICUS system, validating its reliability. Through direct contact with the surface, the auscultation technique helps restorers engage with the problem, while the PICUS map offers a more detailed visualization of the detachment areas. Both helped to focus on the entity of the operations and also on the localization of the pathways to leave open for water drainage and air circulation.

distance available was 235 cm to tighten to about 130 cm in some areas⁷. This has led to some difficulties in framing a significant area, with the IR target very close to the PICUS probe and little maneuvering space for the operator (figure 4.c). For this reason, it was necessary to move the IR target along the perimeter of the scaffold and then acquire six separate measurements in six different framing, which are then overlaid on the photographic reference, as shown in figure 5.a and 5.b.
