# Full-scale tests on masonry vaults strengthened with Steel Reinforced Grout

Stefano De Santis<sup>1\*</sup>, Francesca Roscini<sup>2</sup>, Gianmarco de Felice<sup>3</sup>

Roma Tre University, Department of Engineering. *Via Vito Volterra 62, 00146 Rome, Italy.*

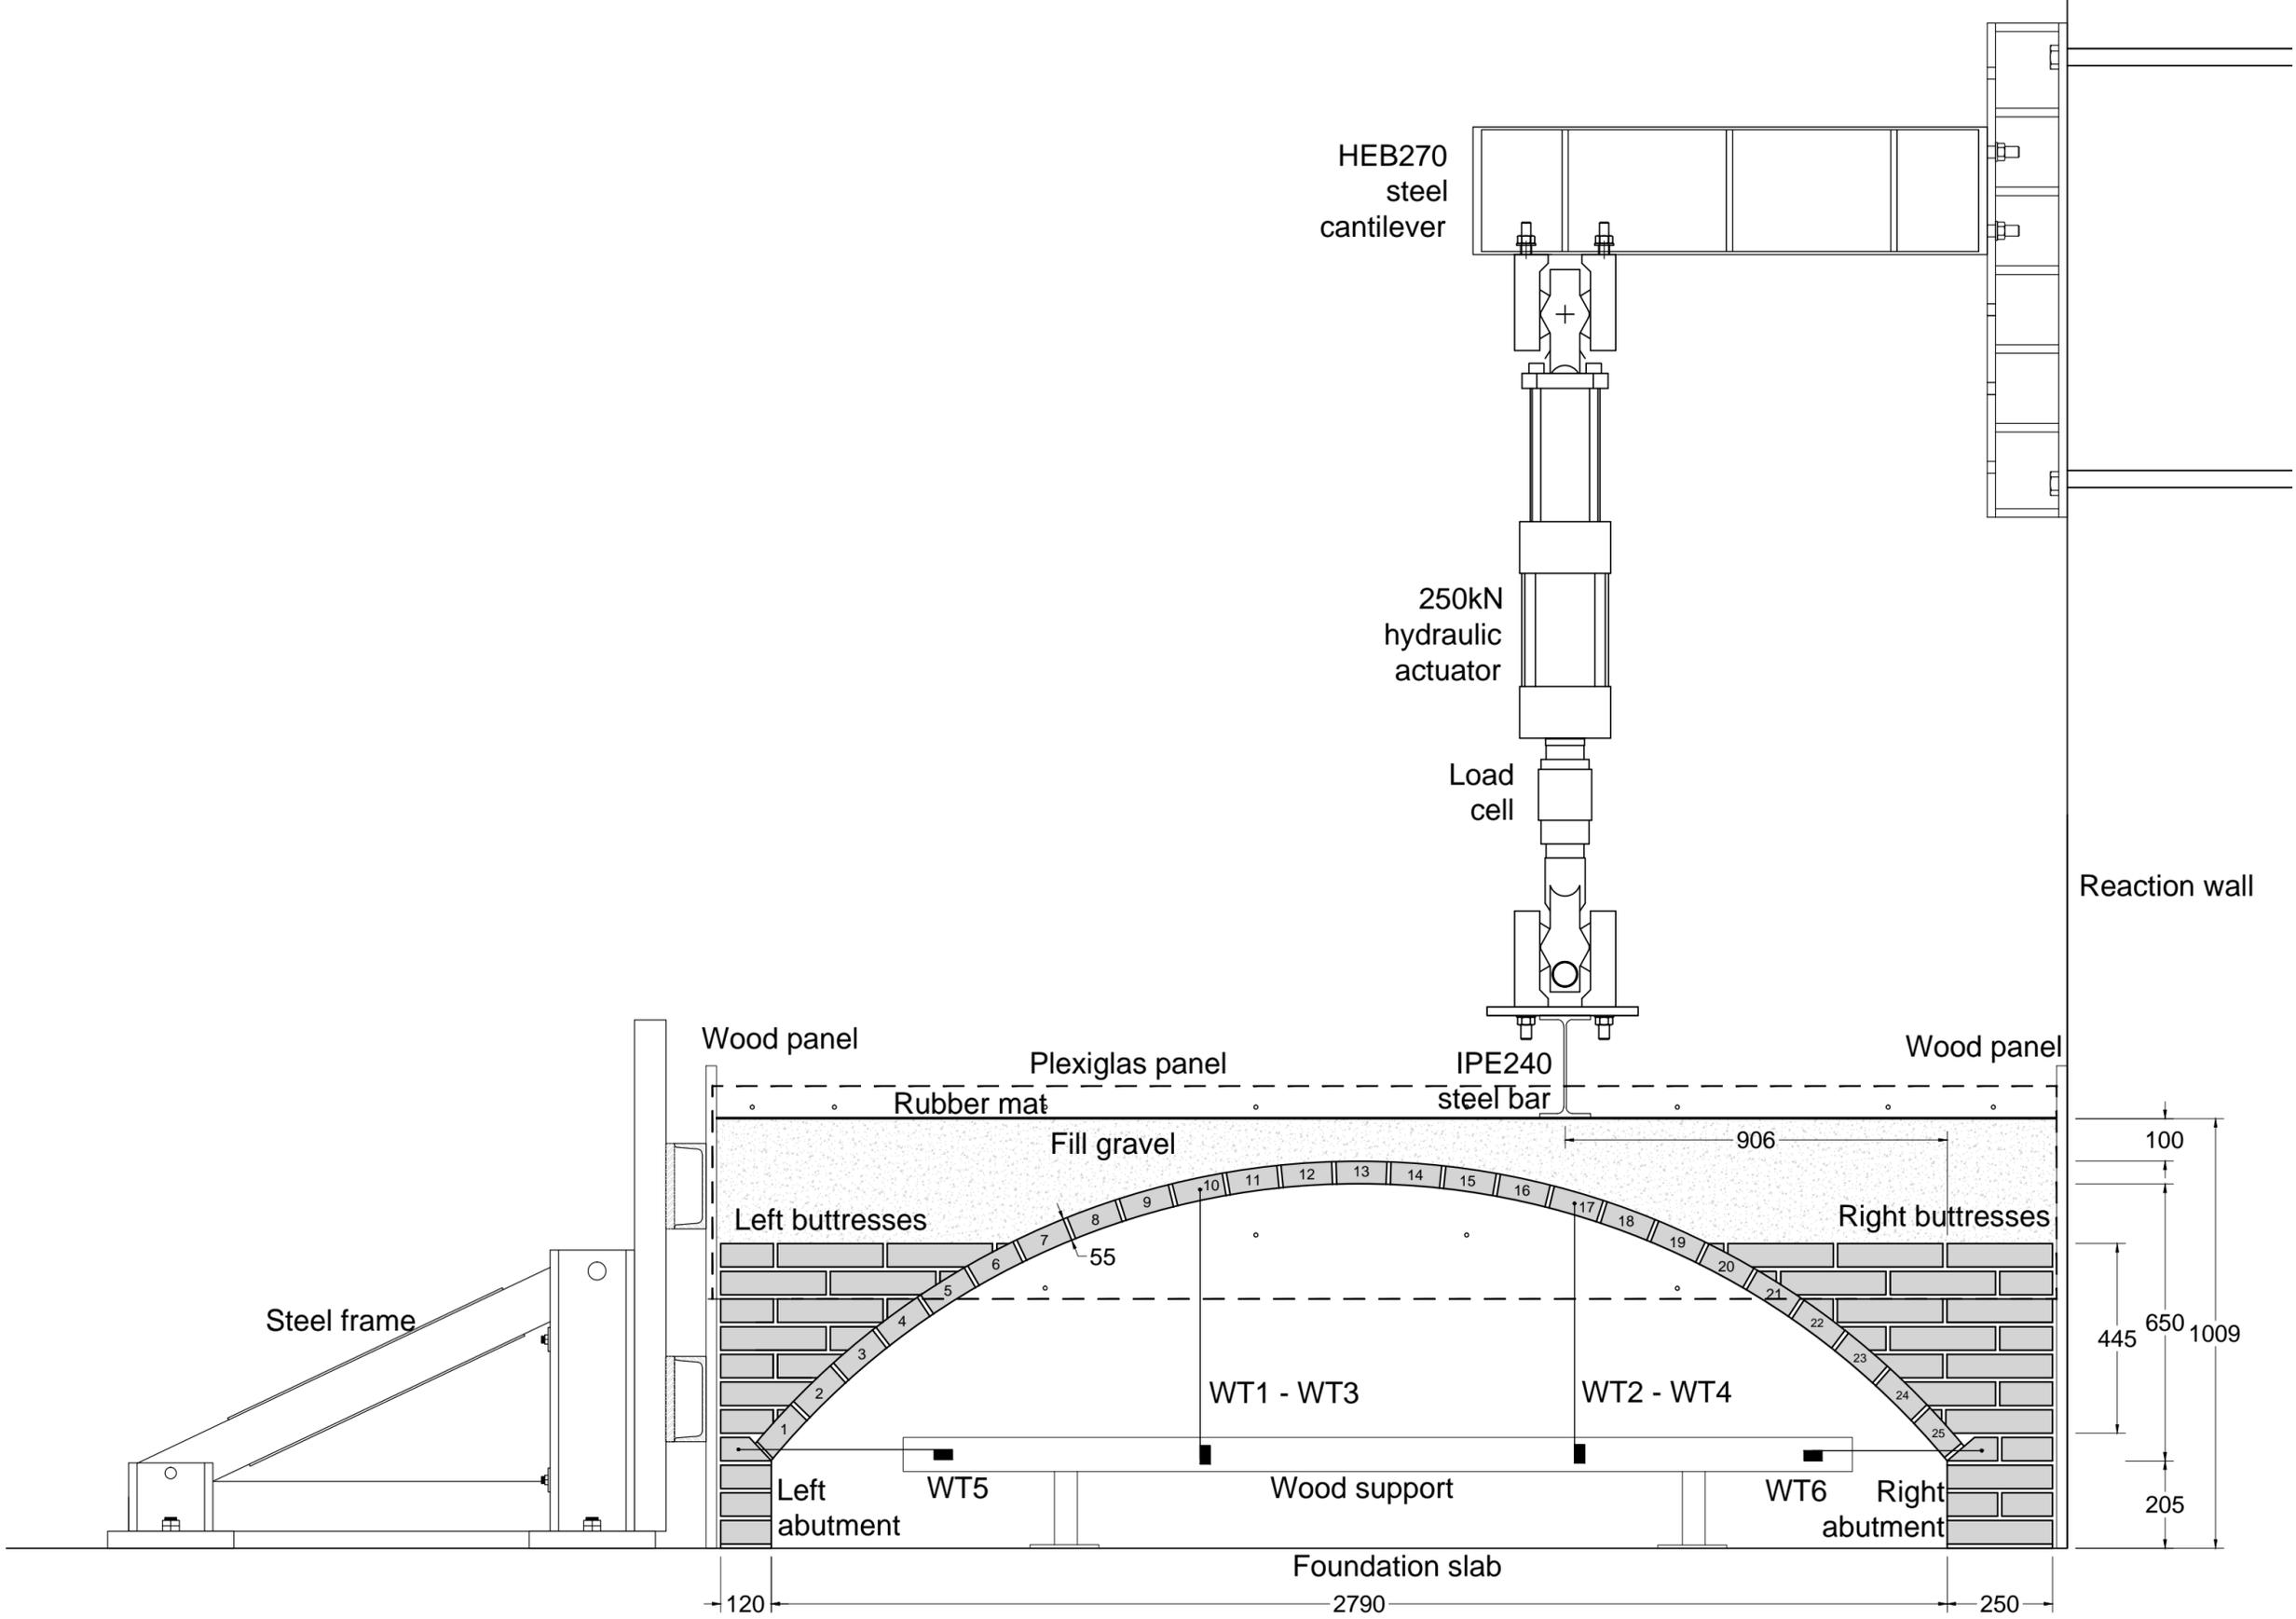
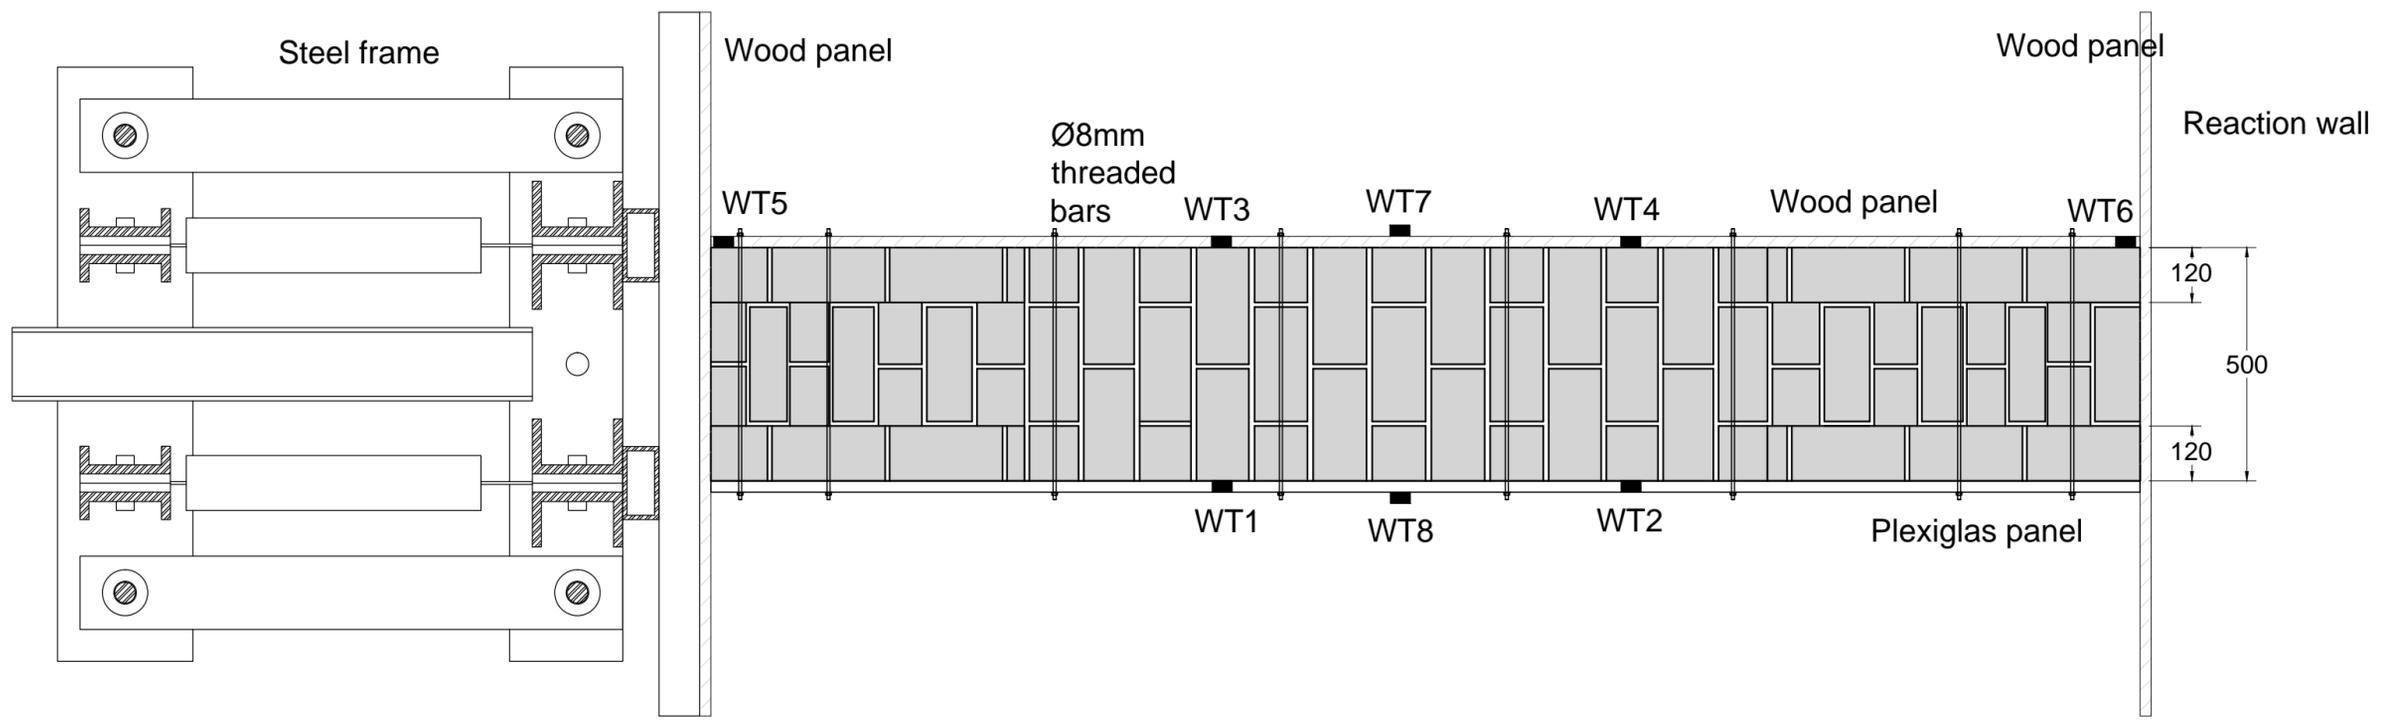
Figure 1. Side and top view of the experimental setup.

The experimental setup was designed to apply the most severe static loading condition that a vault can experience, that is, a concentrated load at 1/3 span [22], and the abutments were fixed. In the field, the relative support movements can be prevented by means of tie-bars [23].

The load was applied at 1/3 span by means of an MTS 250kN hydraulic actuator, fixed to a reaction wall by a HEB270 steel cantilever (Figure 1), and recorded by an integrated load cell. Displacement controlled loading-unloading cycles were performed at 0.05mm/s (loading) and 0.20mm/s (unloading) rate, with increasing amplitude to failure. A 500mm long IPE240 steel bar was bolted to the head of the actuator to distribute the load over the width of the arch specimen and over a 120mm large portion of the rubber mat. The load spread through the gravel down to the vault extrados.

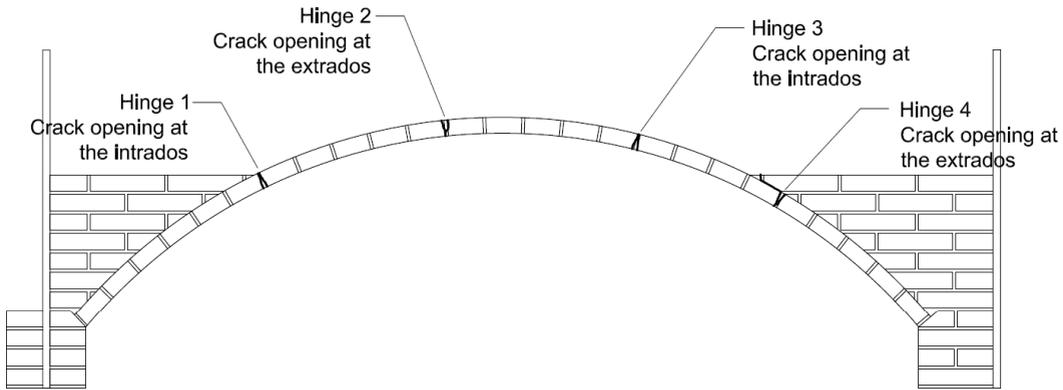
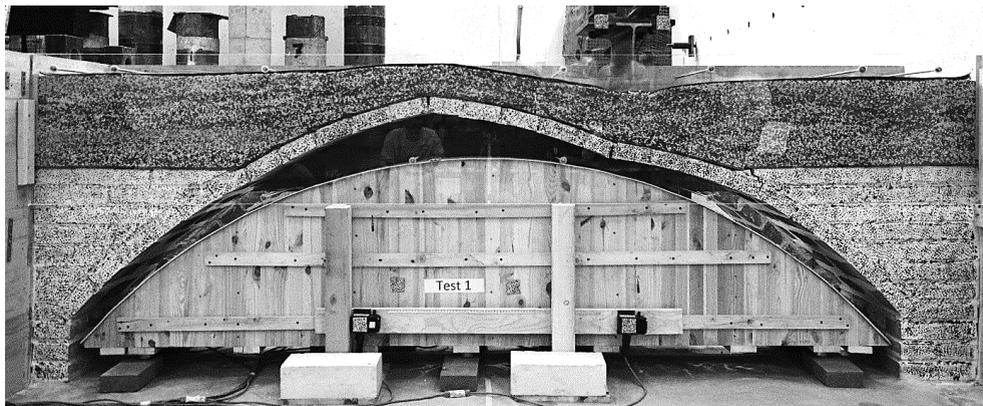
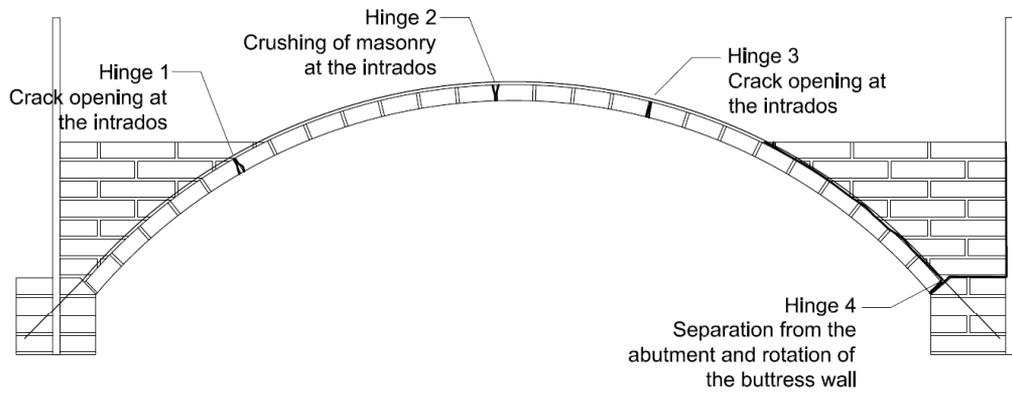
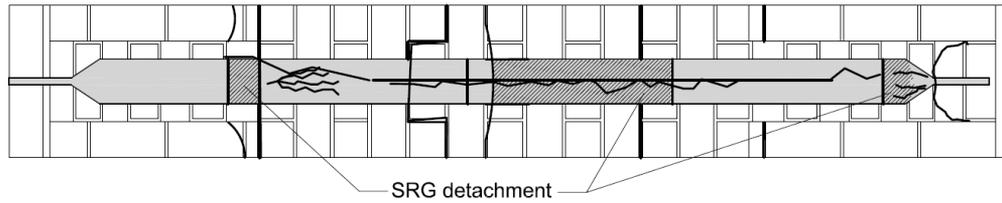
Figure 8. Crack pattern and failure mode of UNR specimen.

In the unreinforced arch (UNR), after the initial cycles that compacted the backfill, cracks appeared on the arch barrel after a load of 4kN was overstepped. This produced a reduction of the stiffness with the development of the first non-negligible vault deflections. A four-hinge mechanism developed, with hinges between bricks 6-7 (crack at the intrados), 11-12 (extrados), 16-17 (intrados, below the load), and 20-21 (extrados), as shown in Figure 8. The hinges in the central region of the arch (11-12 and 16-17) appeared before the peak load, whereas the other ones developed in the post-peak phase. The maximum load was 5.9kN. Then, a post-peak phase took place during which the load carrying capacity decreased linearly. At the end of the test, the displacement of brick 17 was  $s(F_{\max})^+ = 36.1\text{mm}$  (downwards), whereas that of brick 10 was  $s(F_{\max})^- = -38.1\text{mm}$  (upwards). The buttress walls reduced the real span of the arch, especially on its left side, whose upward movement was constrained. On the other side, a crack developed between the extrados of the arch and the buttress, which, therefore, had a negligible influence on the response of the vault since its right portion moved downwards.

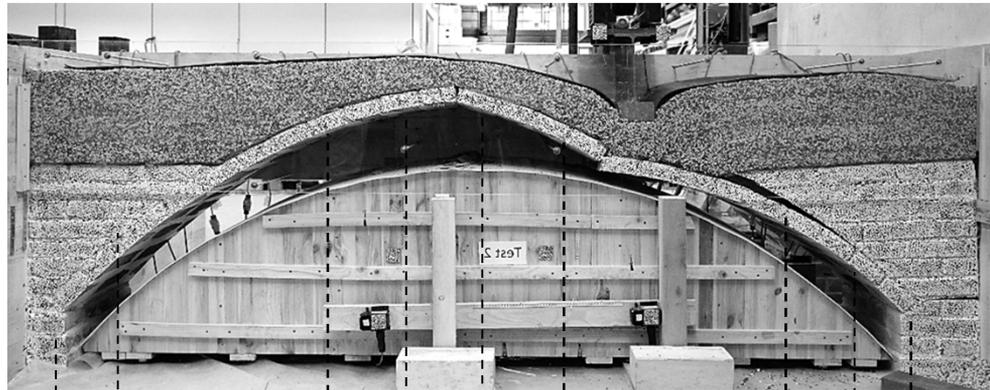
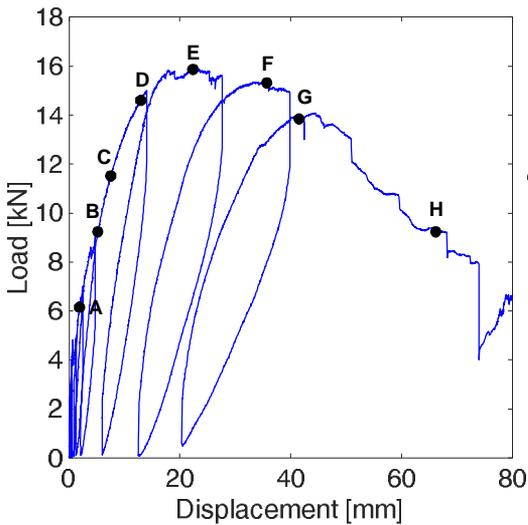
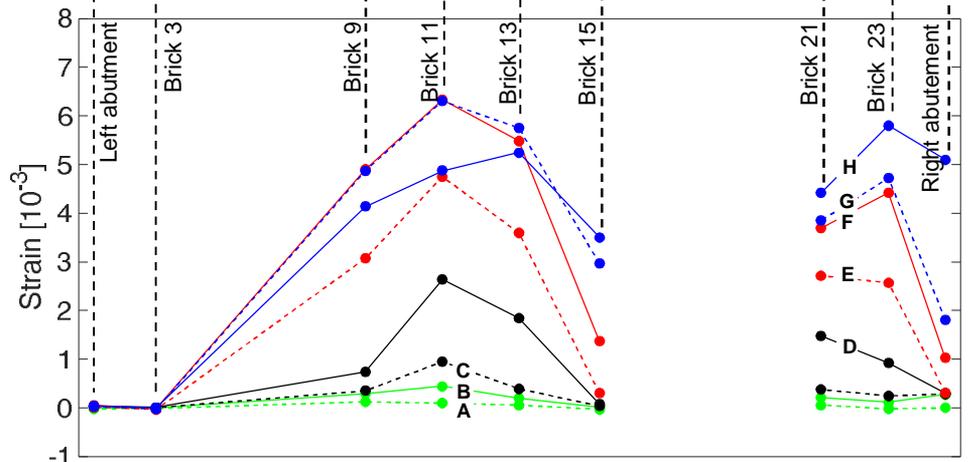
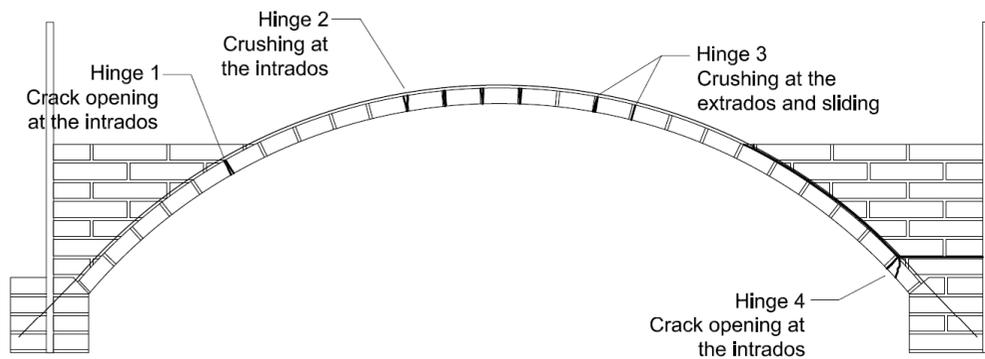
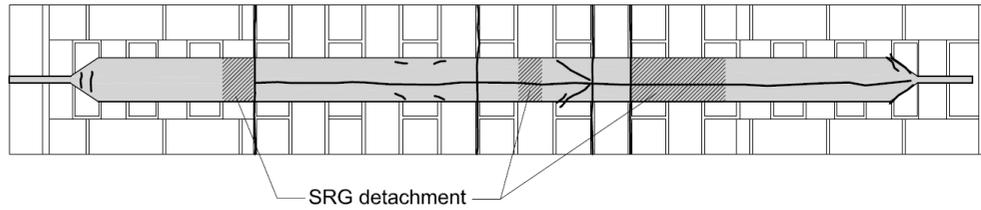
Figure 9. Crack pattern, failure mode and strains in the textile of EX8 specimen.

The vault reinforced with the 8 cord/in textile at the extrados (EX8) attained a maximum load of 15.9kN (+174% with respect to UNR). The SRG limited the opening of cracks at the extrados and the upward deflection of the arch, whereas a crack developed at the intrados between bricks 16-17 (below the load) and between bricks 5-6, also involving the left buttress wall (Figure 9). When approaching the maximum load, detachment activated at the textile-to-matrix interface, cracks appeared also at the extrados between bricks 12-13 (Figure 12b) and between brick 25 and the right abutment. With respect to UNR, the failure mechanism involved a larger portion

of arch barrel, and the four hinges were associated to a shear sliding between bricks 16-17 (Figure 12a) and to a significant crushing of the masonry. Apart from the compressed edges of the bricks at the hinges, a longitudinal crack also appeared in the middle of the arch barrel (Figure 12c), indicating that the reinforcement led to the attainment of a high bending moment, associated to high compressive stresses. At collapse, the vault detached from the right buttress, which was also involved in the failure mode, as it separated from the abutment and rotated around the springing section. Since the SRG was not visible during test execution, progressive damage development could not be detected. After the end of the test, the backfill was removed and the final damage pattern was surveyed. Detachment took place at the textile-to-matrix interface where the extrados was compressed, thus appearing mainly due to instability rather than to shear. On the other hand, the development of cracks at the extrados indicated that some sliding had occurred between the cords and the mortar, reducing the effectiveness of the reinforcement.

The strain in the steel cords at the attainment of the peak load (stage E) was  $2.8 \times 10^{-3}$  (corresponding to a stress of about 515N/mm<sup>2</sup>) and was recorded by the strain gauges placed over brick 11 (Figure 9), whereas the maximum strain value was  $\epsilon_{\max} = 6.7 \times 10^{-3}$ , corresponding to an estimated stress  $\sigma_{\max} = 1230\text{N/mm}^2$ , which is 38.7% of its tensile strength and nearly twice its bond strength (the increase may be attributed both to the convex surface as well as to the longer bond length [23]). Such strain level was reached at brick 11 in the first part of the post-peak phase (stages F and G). Then, it partially reduced to  $5 \times 10^{-3}$  (stage H) when the strain redistributed over a longer portion of SRG (between bricks 9 and 15). The most stressed portion of SRG was far enough from the left abutment that the load was effectively transferred by SRG-to-substrate adhesion and the connector

- Point A:  $s=1.9\text{mm}$   $F=5.8\text{kN}$
- Point B:  $s=5.2\text{mm}$   $F=9.2\text{kN}$
- -●- - Point C:  $s=7.5\text{mm}$   $F=11.5\text{kN}$
- Point D:  $s=12.9\text{mm}$   $F=14.5\text{kN}$
- -●- - Point E:  $s=22.8\text{mm}$   $F=15.9\text{kN}$
- Point F:  $s=35.6\text{mm}$   $F=15.3\text{kN}$
- -●- - Point G:  $s=41.5\text{mm}$   $F=13.8\text{kN}$
- Point H:  $s=66.1\text{mm}$   $F=9.2\text{kN}$

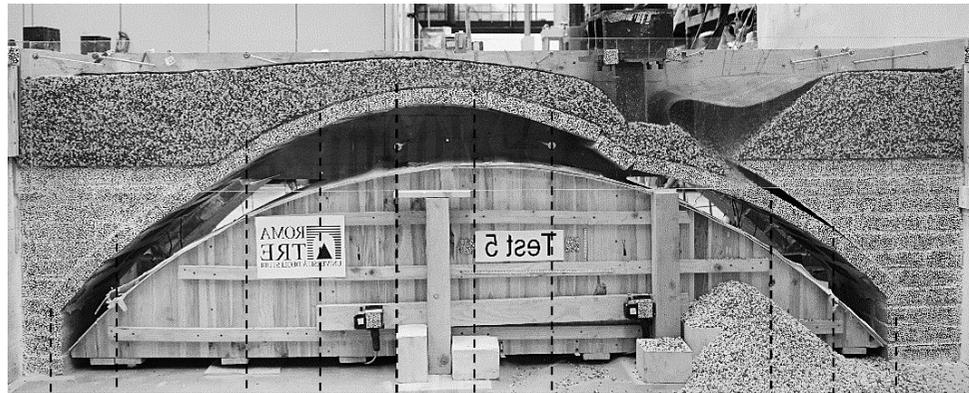
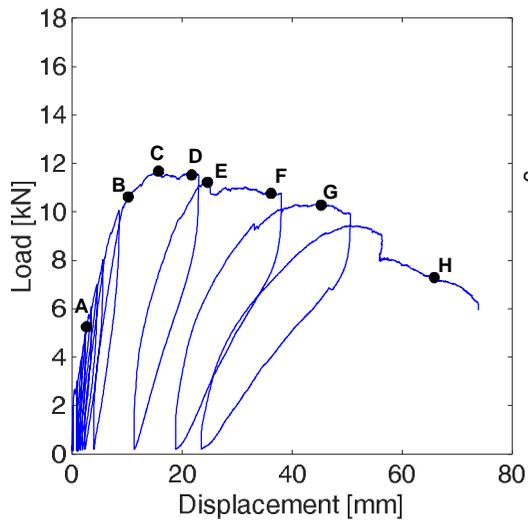
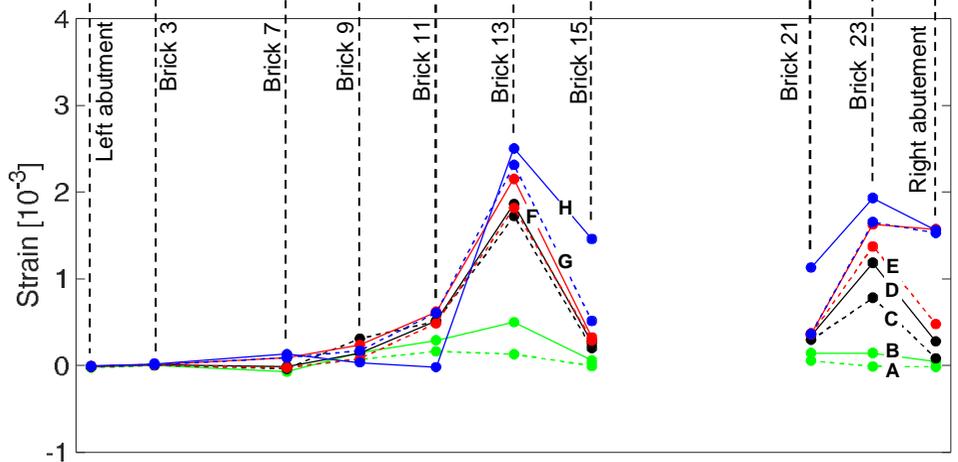
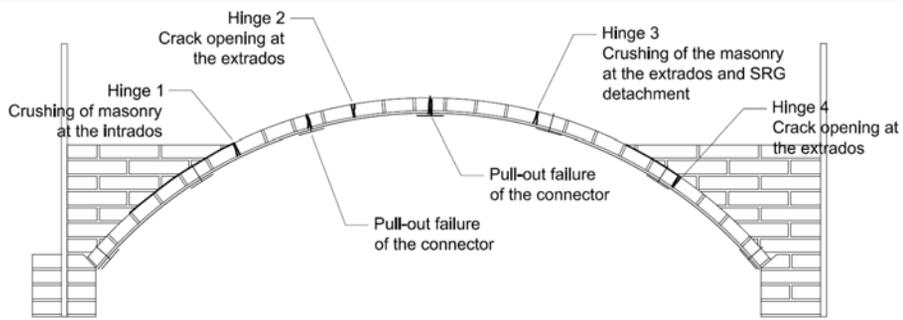
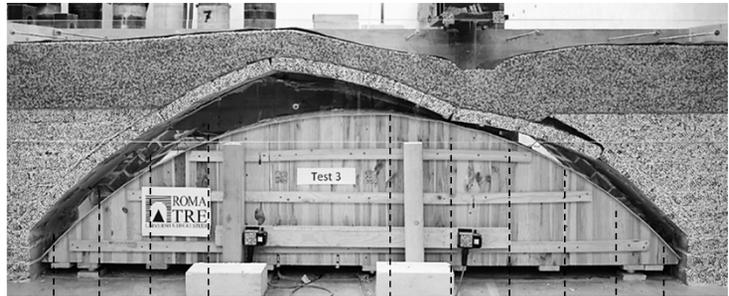
Figure 10. Crack pattern, failure mode and strains in the textile for EX4 specimen.

EX4 specimen (reinforced at the extrados with the 4 cord/in textile) attained a maximum load of  $F_{\max}=11.7\text{kN}$  (+102%), with a displacement of brick 17 of  $s(F_{\max})^+=15.8\text{mm}$  (Figure 7). Failure occurred by shear sliding between bricks 16-17 and 17-18 (Figure 12d), at  $s_u^+=73.9\text{mm}$ . Cracks also appeared at the intrados between bricks 5-6, at the extrados between bricks 11-12 and 13-14, and, finally, at the extrados between brick 25 and the right abutment, with a detachment from the buttress (Figure 10). The position of the hinges was analogous to EX8. In EX4, however, no detachments were detected in the SRG (thanks to the better textile-to-matrix interlocking of the 4 cord/in textile with respect to the denser 8 cord/in one), apart from where shear failure took place and over bricks 6-8, which was probably related to a local dip of the vault surface (Figure 12e). A longitudinal crack developed (Figure 12f), but if it was narrower than in EX8, due to the lower applied load. The lower load carrying capacity with respect to EX8 may be attributed to the larger deformability of the SRG (which did not constrain the arch deflections with the same effectiveness), but also to local imperfections or initial misalignments of the bricks in the arch barrel below the load, where shear sliding occurred.

The displacement capacity of EX4 was similar to that of EX8, with an even slightly larger ultimate upward displacement ( $s_u^-$ ), associated to a less steep post-peak branch, due to the lower axial stiffness of the reinforcement (Figure 7). Indeed, the deformed configurations at peak and at collapse show only slightly larger displacements of the entire left portion of the vault (moving upwards, Figures 13c,d, 14c,d and 15c,d). The displacements measured by DIC indicate that these larger displacements were associated to a higher concentration in the backfill over the extrados on the left side (Figures 14c and 15c).

- Point A:  $s=2.6\text{mm}$   $F=5.8\text{kN}$
- Point B:  $s=7.6\text{mm}$   $F=8.3\text{kN}$
- -●- - Point C:  $s=15.8\text{mm}$   $F=11.7\text{kN}$
- Point D:  $s=21.8\text{mm}$   $F=11.5\text{kN}$
- -●- - Point E:  $s=24.5\text{mm}$   $F=11.2\text{kN}$
- Point F:  $s=36.1\text{mm}$   $F=10.7\text{kN}$
- -●- - Point G:  $s=45.2\text{mm}$   $F=10.3\text{kN}$
- Point H:  $s=65.8\text{mm}$   $F=7.3\text{kN}$

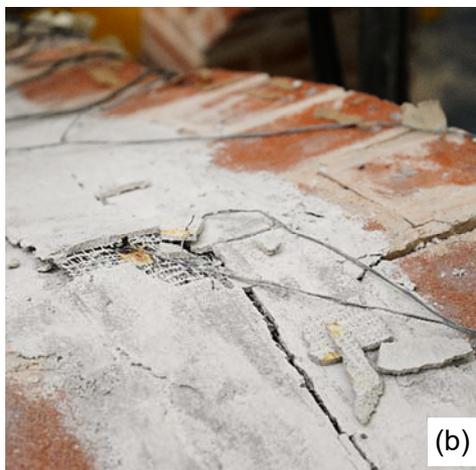
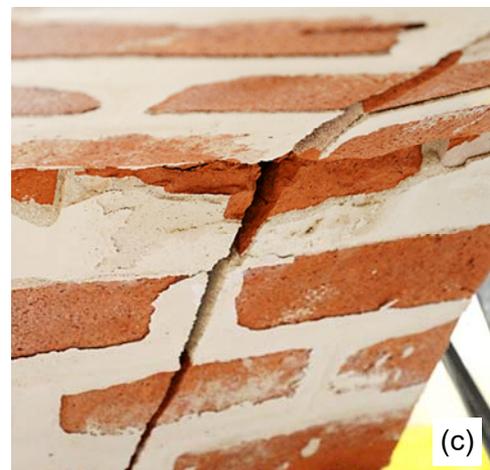
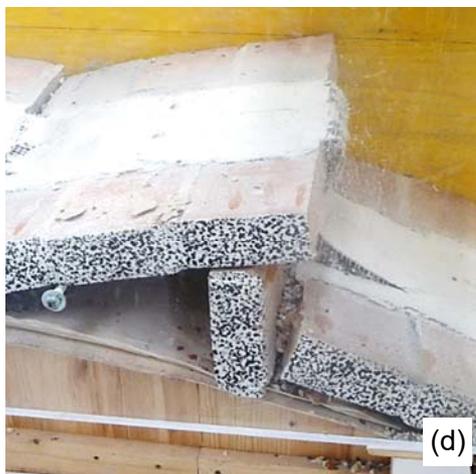
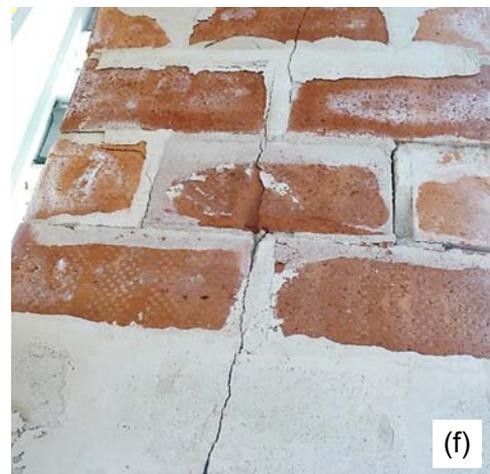
Figure 12. Damage pattern surveyed after the test on EX8 (a-c), EX4 (d-f) and IN4 (g-i) vault specimens.

After the detachment of SRG, hinges developed between bricks 6-7 (intrados), 10-11 (extrados), 16-17 (at the intrados, below the load), and 21-22 (extrados, with detachment from the buttress wall), as shown in Figures 11 and 12i. The masonry locally cracked where the hinges formed. The left buttress also cracked and detached from both the arch barrel and the abutment, but it was not directly involved in the collapse mechanism. Cracks in the buttress mainly developed during the unloading cycles due to its lower capacity of following the downwards deflection of the underlying vault that took place when the load decreased.

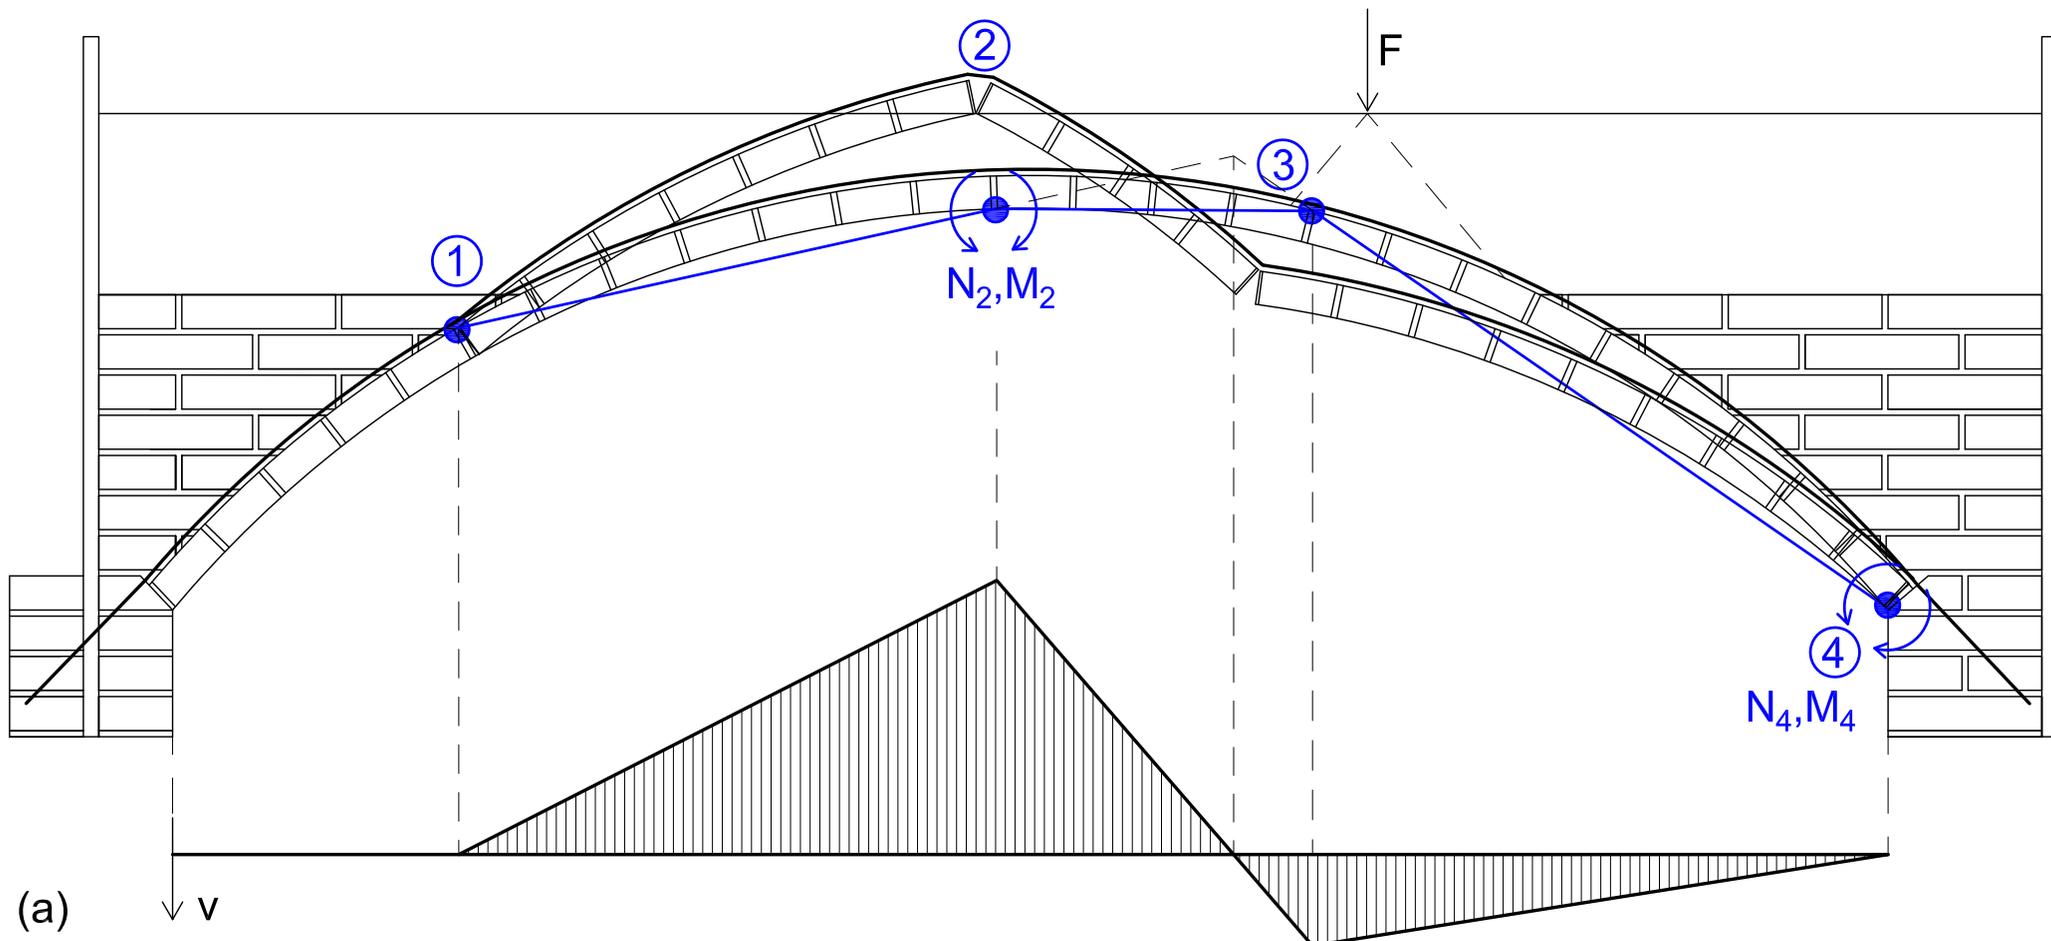
(a)

In the static approach, the axial force (N) - bending moment (M) strength domain of the cross section is built for the vault reinforced at the extrados (Figure 17a) and at the intrados (Figure 17b). A compressive strength of the masonry of  $8\text{N/mm}^2$  is considered and it is assumed that failure is attained at the same time in the masonry and in the SRG. In the arch reinforced at the extrados, starting from the position of the hinges provided by experiments (Figure 16a), equilibrium is obtained requiring that the stress resultant in sections 1 and 3 (see Figure 17a) is applied at the hinges. The maximum statically and plastically admissible load  $F_{\max}$  is then obtained by imposing that in sections 2 and 4, the N,M stress state falls on the boundary of the domain. According to this approach, the balance and strength conditions are established only at the hinge sections. The static approach provides an estimated  $F_{\max}$  of  $14.0\text{kN}$  (-12% with respect to the experimental value). In a similar manner, for the arch reinforced at the intrados (figure 16b), the maximum load that is in equilibrium and satisfies the strength condition in Figure 17b is equal to  $14.1\text{kN}$ , which is 13% lower than the experimental value.
