## **Bond behaviour of Steel Reinforced Grout for the extrados strengthening of masonry vaults**

**Stefano De Santis**

Roma Tre University, Department of Engineering, *Via Vito Volterra 62, 00146 Rome, Italy.*  
E: stefano.desantis@uniroma3.it. T: +39 06 5733 6387. F: +39 06 5733 3441.

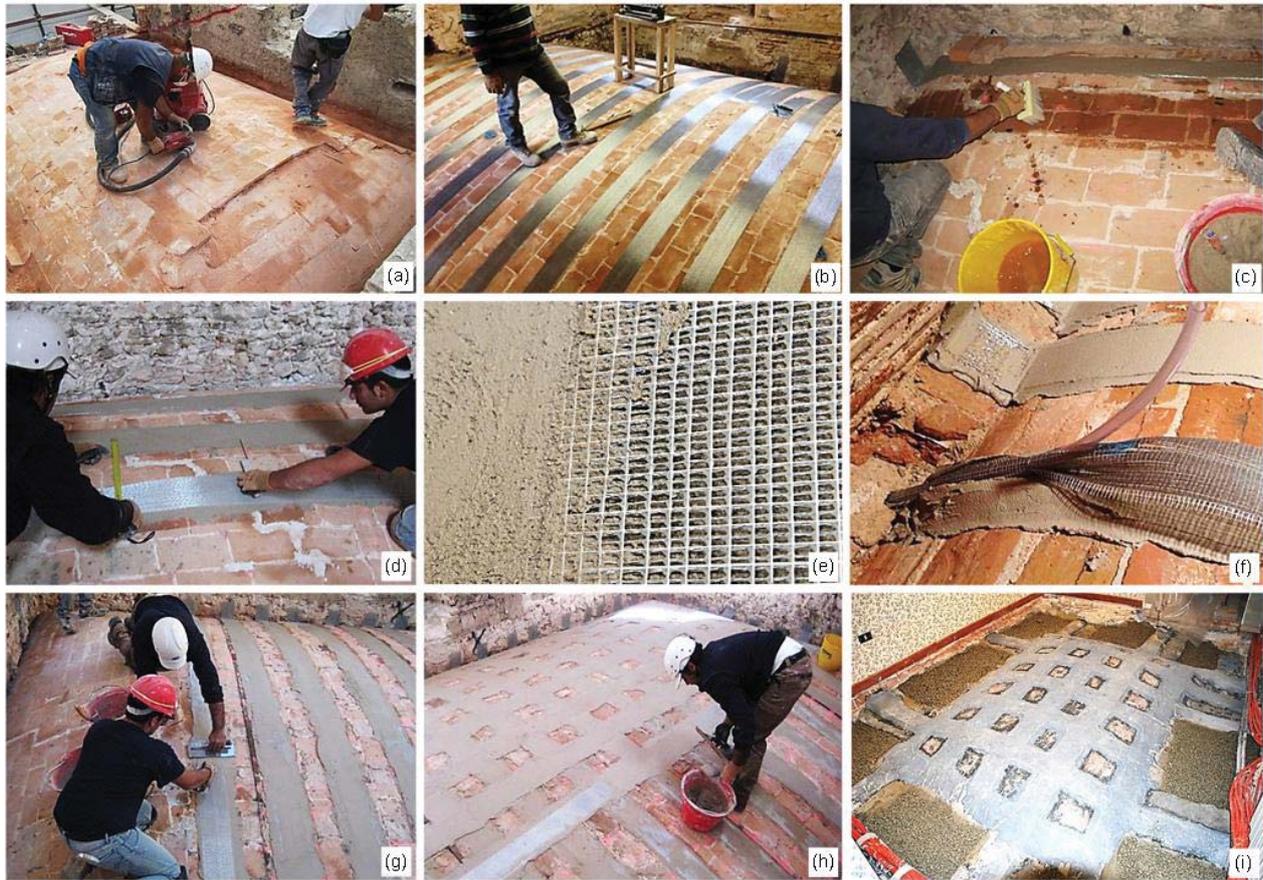
Figure 1. Phases of the installation of SRG to the extrados of a brickwork vault.

- 98 (iv) the surface of the vault is cleaned and residues of mortar and filling are removed, and (if in the design)  
99 the roughness of the vault surface is improved artificially (e.g., by bush hammering) (Figure 1a);

- 100 (v) the strips of steel textile are cut to size (Figure 1b);
- 101 (vi) the surface of the vault is wet with water (Figure 1c);
- 102 (vii) the first mortar layer (having thickness of about 5mm) is laid down;

- 103 (viii) the steel textile is installed (Figure 1d) taking care of the full protrusion of the mortar between the  
104 cords (Figure 1e);
- 105 (ix) the end connectors are prepared, installed and injected in drilled holes at the abutments (Figure 1f);

- 106 (x) the top layer of mortar (5mm thickness) is laid (Figure 1g);
- 107 (xi) a second transversal set of strips is installed (Figure 1h), if foreseen by the design (usually in vaults  
108 with double curvature);

- 109 (xii) tie-bars are installed and side buttresses or backings are built in solid brickwork; new fill material is  
110 placed (Figure 1i). This latter may include a grout that contributes to the constraining the deflection of  
111 the vault and/or lightened aggregates (e.g., expanded clay) to reduce the vertical load.

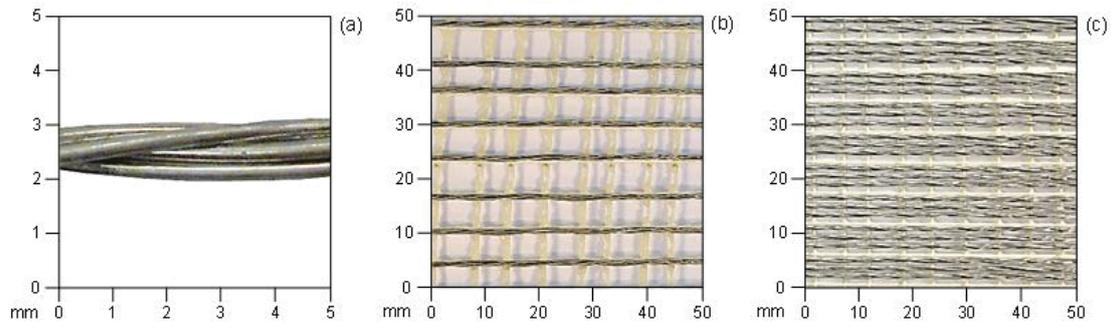
Figure 2. Ultra High Tensile Strength Steel (UHTSS) textiles: detail of the steel cord (a), textiles with 4 cord/inch (S4, b) and 12 cord/inch (S12, c).

The SRG systems used in this study comprise unidirectional textiles of UHTSS cords (Figure 2a). Cords are made of five wires with  $0.11\text{mm}^2$  cross section area, three rectilinear and two twisted around them at a short lay length to enhance the interlocking with the mortar. Wires are galvanized (coated with zinc) to provide protection against rusting, and are fixed to a supporting glass mesh to ease handling and installation. Two textiles differing only for their density (i.e., 4 cord/inch, corresponding to 0.158 cord/mm and 12 cord/inch corresponding to 0.474 cord/mm) were used. In the former (S4, Figure 2b), the cords are spaced 6.35mm, the design thickness is 0.084mm, and the surface mass density is  $670\text{g/m}^2$ . In the latter (S12, Figure 2c), cords are spaced 2.12mm, the design thickness is 0.254mm and the surface mass density is  $2000\text{g/m}^2$ .

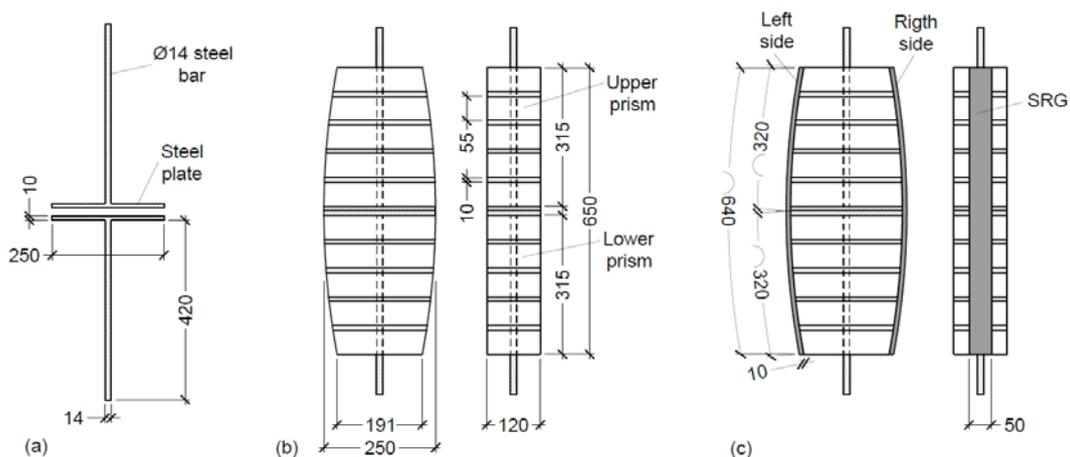
Figure 3. Specimen geometry: steel bars and plates (a) and brickwork prisms before (b) and after (c) SRG installation (specimen with  $R=1800\text{mm}$  and  $L_b=320\text{mm}$  shown as sake of example).

132 In order to investigate the bond behaviour of SRG applied to convex masonry substrate, shear tests were  
133 carried out in the laboratory with a double-lap double-prism setup (Figure 3). Each specimen consisted of  
134 two brickwork prisms (an upper prism and a lower prism) connected to each other by two SRG strips (one on  
135 the left side and one on the right side). The two prisms were moved apart to apply a tensile load to the SRG  
136 strips, simulating the loading condition that would be caused by the development of a crack in the vault  
137 substrate [10].

147 Before manufacturing the prisms, the bricks were shaped by realizing inclined cuts at their sides, to obtain  
148 curved substrates with uniform radius (Figure 3b). The SRG strips were bonded to the curved surfaces of the  
149 prisms for the whole length (Figure 3c). Each specimen comprised four reinforcements nominally identical  
150 (left upper, left lower, right upper, and right lower).

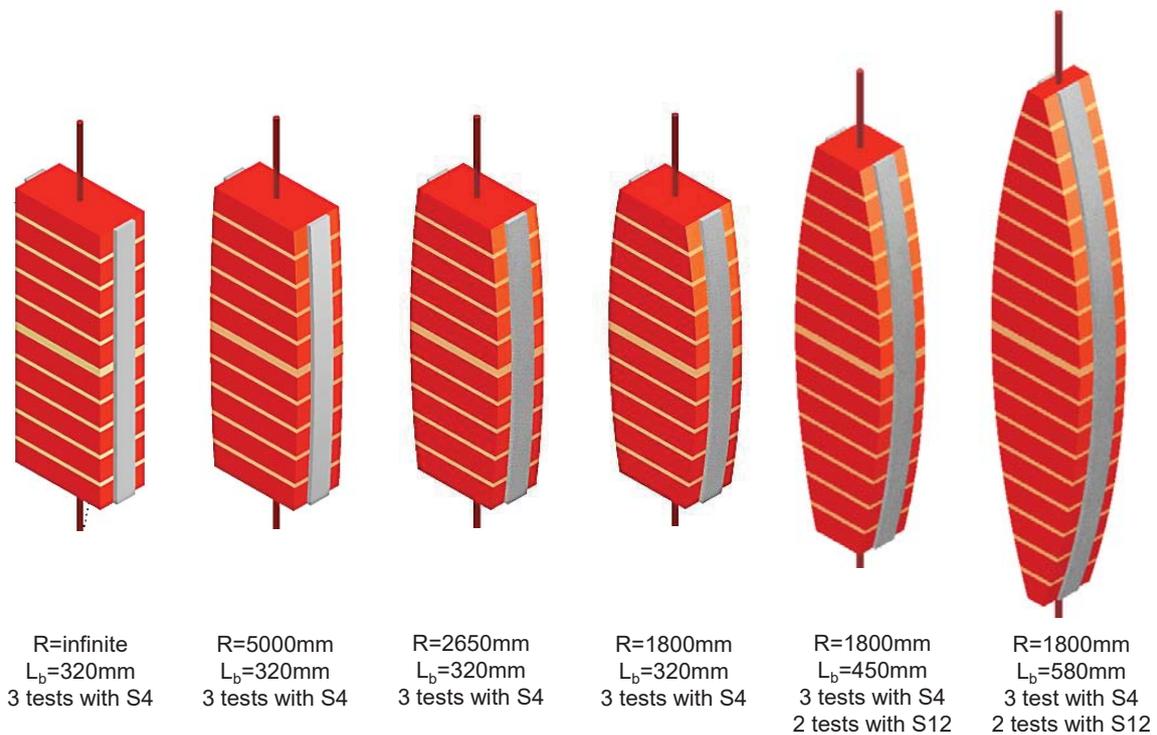
Figure 4. Specimen types.

Nine tests were carried out with the S4 textile on prism substrates comprising 5 bricks and four mortar joints, resulting in a bonded length of  $L_b=320\text{mm}$ . Three values of the curvature radius were tested, including  $R=5000\text{mm}$ ,  $R=2650\text{mm}$ , and  $R=1800\text{mm}$ . Three specimens with plane surface ( $R$  infinite) were tested and taken as a reference for comparisons. Six additional specimens with  $R=1800\text{mm}$  were tested, three with 7 and three with 9 brick layers, corresponding to  $L_b=450\text{mm}$  and  $L_b=580\text{mm}$ , respectively. Finally, S12 textile was applied to two specimens with 7 layers and two specimens with 9 layers, all having  $R=1800\text{mm}$  (Figure 4). SRG reinforcements were 50mm wide. The strips of S4 textile comprised 8 cords and had a cross section area of  $4.26\text{mm}^2$ , while those of S12 had 24 cords and  $12.80\text{mm}^2$  area. The cross section area can be evaluated as the number of cords multiplied by their individual area ( $0.534\text{mm}^2$ ), or as the design thickness ( $0.084\text{mm}$  for S4 and  $0.254\text{mm}$  for S12) multiplied by the width of the textile ( $50.8\text{mm}$ ), the latter being the product of the number of cords (8 or 24) and of their spacing ( $6.35\text{mm}$  or  $2.12\text{mm}$ ).

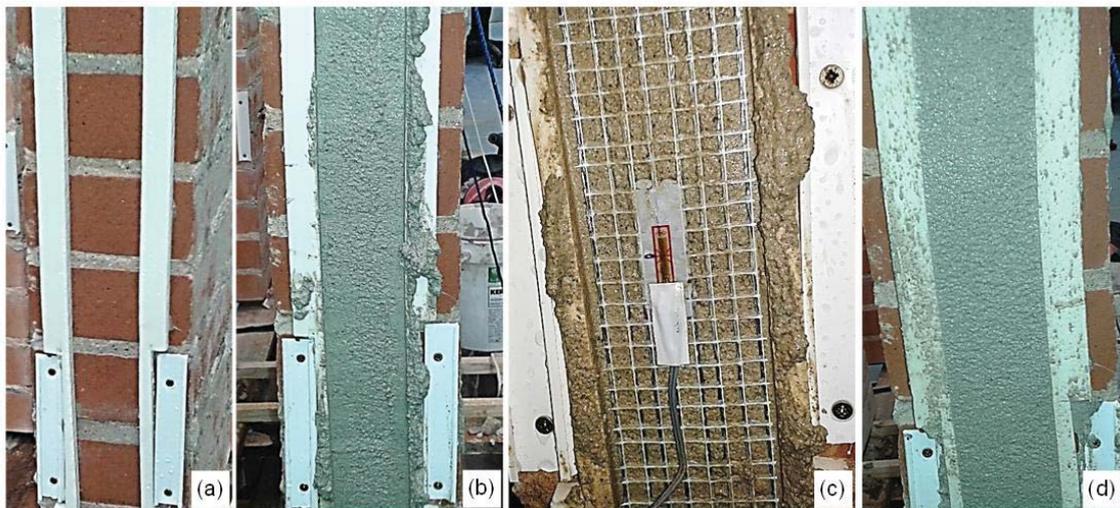
250 Figure 5. Manufacturing of the specimens: preparation of the surface of the brickwork substrate and positioning of the  
251 polyethylene frameworks (a), laying of the first layer of mortar matrix (b), installation of the steel textile (c) and laying of the top  
252 layer of mortar (d).

181 A first 5mm thick layer of mortar was laid down within polyethylene frameworks placed in the middle of the  
 182 substrate (Figures 5a,b). The steel textiles were manually placed on the first mortar layer and pressed enough  
 183 to make the fresh mortar protrude through the voids between steel cords (Figure 5c). Finally, a 5mm thick

184 layer of mortar was laid on top (Figure 5d). In order to reproduce the condition that an SRG reinforcement  
185 would experience in field applications, specimens were not provided with an initial interfacial notch  
186 (distance between the loaded end of the bonded area and the edge of the substrate block). Specimens were  
187 kept wet (R.H.>95%) for 15 days and then stored, for at least other 25 days, in the laboratory before testing.  
188 In order not to compromise the possible repeatability of these tests, and given the large variability of  
189 temperature and humidity at a construction site, no attempt was made to reproduce the curing conditions that  
190 a reinforcement would experience in field applications.

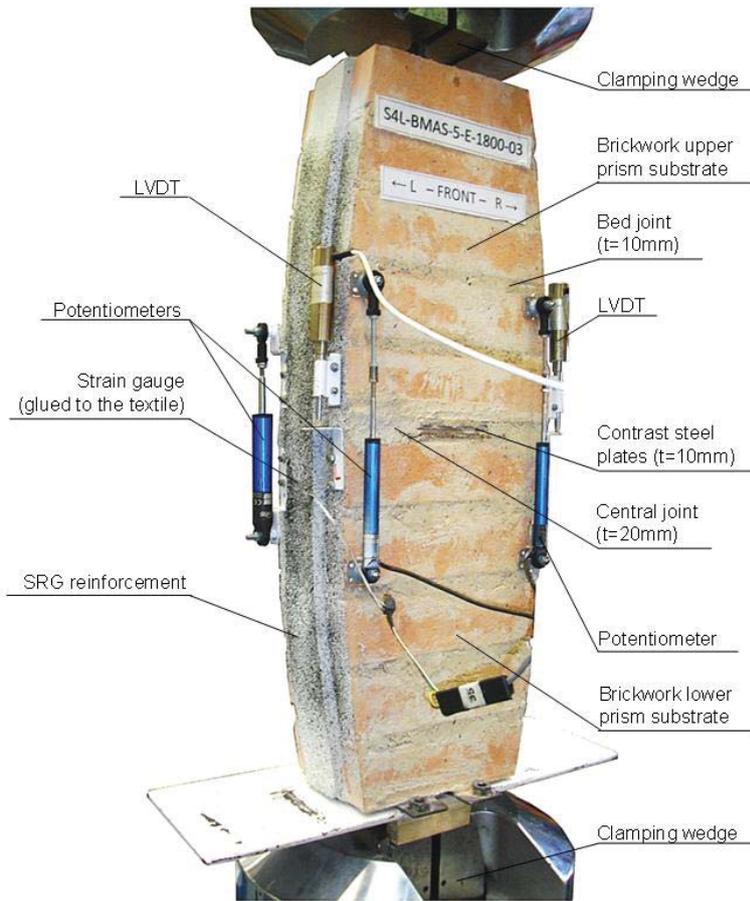
Figure 6. Experimental setup for laboratory tests.

191 Tests were carried out using a Material Testing Systems (MTS) load frame (Figure 6). Load was applied by a  
192 500kN hydraulic actuator under displacement control at 0.003mm/s rate, and recorded by a load cell  
193 integrated in the testing machine. It was then distributed between the two sides of the specimen (i.e., between  
194 the two SRG strips), proportionally to the strain recorded by the strain gauges. One LVDT and one  
195 potentiometer were fixed with threaded bars on each side of the specimen, where SRG reinforcements were  
196 applied. In addition, two potentiometers were also placed on the front and back faces, which measured over a  
197 longer gage length (distance between the points where the device is fixed to the specimen). Data were  
198 acquired at 10Hz sampling frequency in LabView environment.

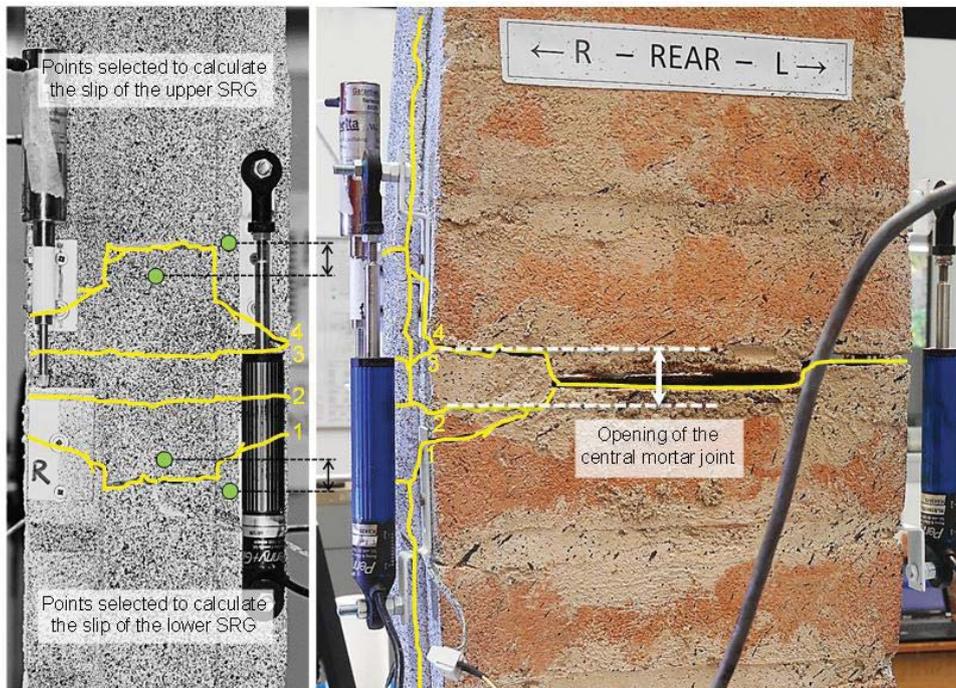
Figure 7. Identification of the cracks developed in the central portion of the specimen and selection of the points for calculating the slip with DIC.

220 Pictures were analysed to derive the relative displacement between reinforcement and substrate (slip) for the  
221 upper and lower portions, and for the left and right sides of the specimen. Therefore, in total, four slip values  
222 were calculated at each time instant (i.e., every 10s). Clearly, the two slip values (upper and lower) measured  
223 on one side were associated to the same load. To calculate each of these slip values, two points were  
224 selected, one on the reinforcement and one on the substrate (Figure 7), across the first crack starting from the  
225 loading plate, and their relative vertical displacement was measured. Since the crack pattern changed from  
226 test to test, the exact location of the measurement points was established after the end of the test based on the  
227 crack pattern, taking advantage of the possibility offered by DIC to select the measurement points in the

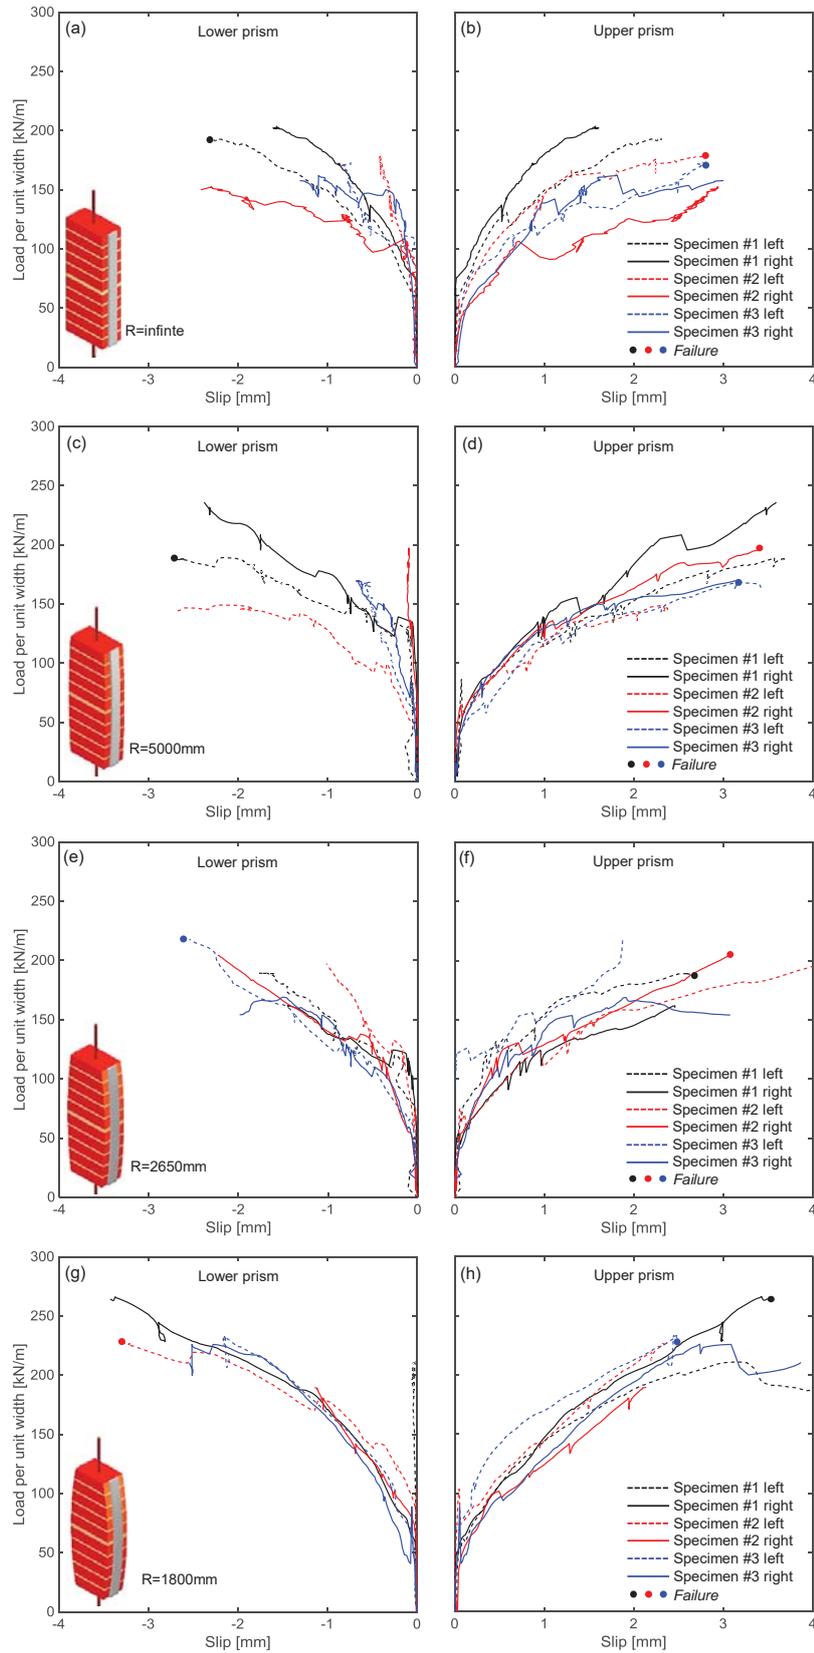
302 Figure 8. Load slip response curves for specimens with S4 textile,  $L_b=320\text{mm}$ , and curvature radius  $R=\text{infinite}$  (plane surface, a,b),

$R=5000\text{mm}$  (c,d),  $R=2650\text{mm}$  (e,f), and  $R=1800\text{mm}$  (g,h).

259 The load-slip response curves of the shear bond tests carried out in the laboratory are shown in Figures 8 and  
260 9. The slip (on the x-axis of the plots) was calculated for each bonded area with the Digital Image  
261 Correlation, while the load per unit width in the reinforcement (on the y-axis) was derived for each side as  
262 the load divided by the width of the steel textile (50.8mm). The specimens of Figure 8 have bond length  
263  $L_b=320\text{mm}$  and are collected by curvature radius of the substrate (R), namely R infinite (Figures 8a,b),  
264  $R=5000\text{mm}$  (Figures 8c,d),  $R=2650\text{mm}$  (Figures 8e,f), and  $R=1800\text{mm}$  (Figures 8g,h). For each specimen,  
265 four response curves were derived, one per each bonded area. Those referred to the lower prism are shown in  
266 plots a,c,e,g (with negative slip values), while those related to the upper prism are in plots b,d,f,h (positive

267 slip). In each plot, there are three curves related to the left side (dotted line) and three curves related to the  
268 right side (solid line). Clearly, for each specimen and for each side (left/right) the load on the upper prism is  
269 equal to that of the lower prism. Finally, for each specimen, a round marker indicates where, among the four  
270 bonded areas, failure occurred. The specimens of Figure 9 have  $R=1800\text{mm}$  and are gathered on the base of  
271 the bond length ( $L_b=450\text{mm}$  in plots a,b,e,f and  $L_b=580\text{mm}$  in plots c,d,g,h) and the type of steel textile (S4  
272 in plots a-d and S12 in plots e-h).

273 All the specimens exhibited an initial uncracked behaviour, associated to a stiff response (Figures 8-9). The  
274 slip increased at the occurrence of a horizontal crack at the central mortar bed joint (between the two prisms,  
275 Figure 10a). A longitudinal crack, visible from the side of the mortar layer (Figure 10b) also appeared at the  
276 textile-to-matrix interface. Then, horizontal cracks developed, crossing the entire thickness of the SRG in  
277 correspondence with the bed joints of the masonry (Figure 10c), together with the propagation of the  
278 longitudinal crack. The occurrence of cracks was associated to load drops in the response curves (Figures 8-  
279 9). Despite the behaviour was never symmetric between the two portions (upper/lower) of the reinforcement,  
280 comparable slip values were generally measured. In some cases, however, the slip concentrated on one prism

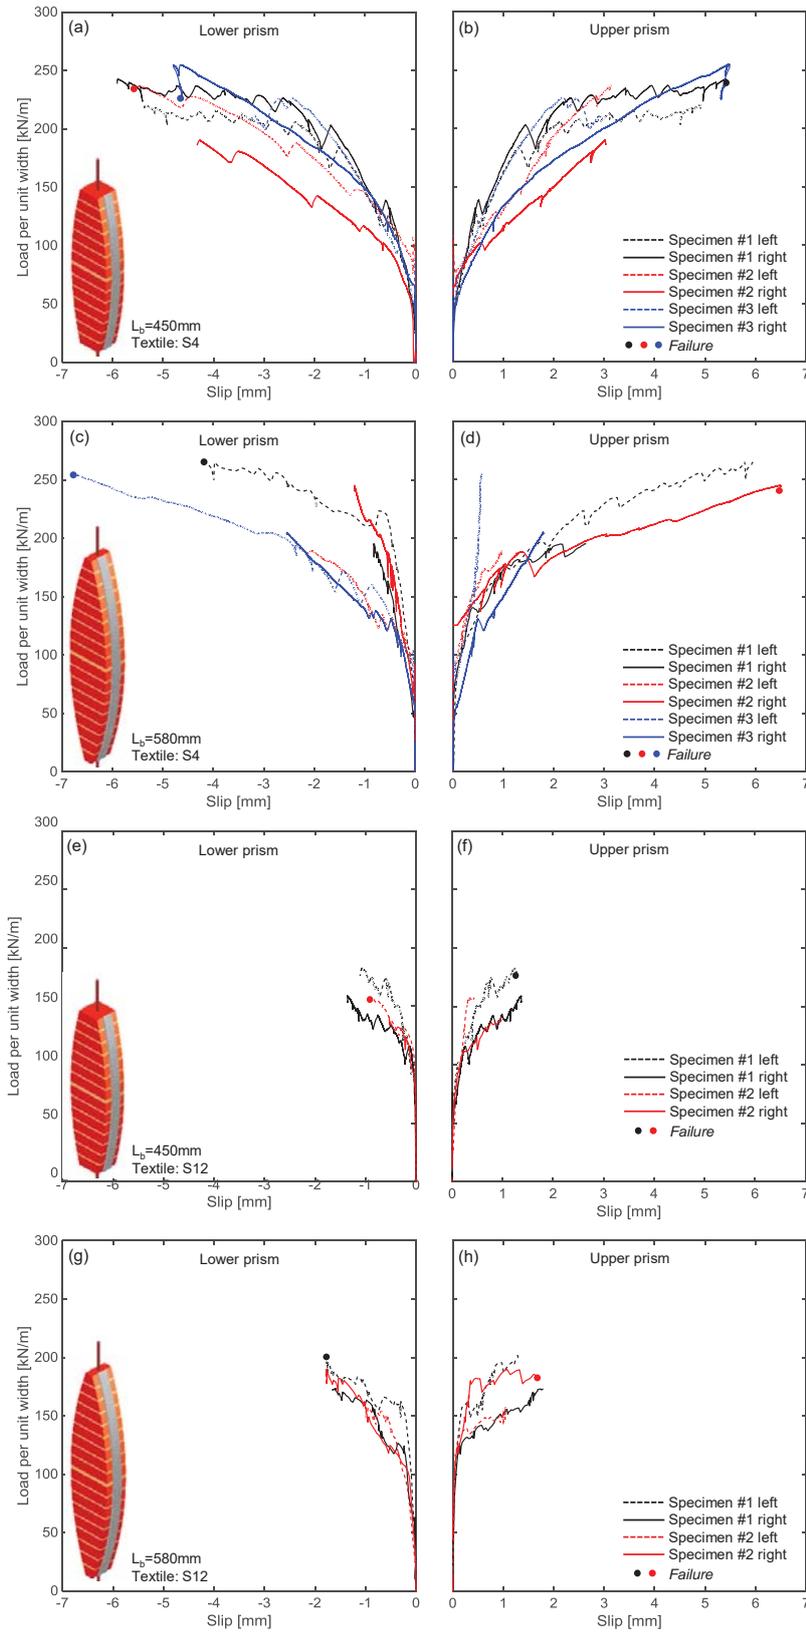
308 Figure 9. Load slip response curves for specimens with S4 (a,b,c,d) and S12 (e,f,g,h) textiles,  $L_b=450\text{mm}$  (a,b,e,f) and  $L_b=580\text{mm}$

(c,d,g,h) and curvature radius 1800mm.

338 It is worth noting that, in the laboratory tests carried out in this research, the bond length did not affect  
339 friction as much as curvature, so other investigations would be needed with longer bond lengths to develop a  
340 deeper understanding of this issue and the field tests described in the following section of the paper aim at  
341 providing a first contribution. Finally, the increase of bond length entailed a longer portion of SRG subjected  
342 to elongation, resulting in higher values of the peak slip values, which grew from  $3.06\text{mm}$  to  $5.82\text{mm}$   
343 (Figures 9a-d and 12d).

344 Since the exploitation ratios achieved in these tests were very close to 100%, it was decided to manufacture  
 345 four specimens with  $R=1800\text{mm}$ , two with  $L_b=450\text{mm}$  and two with  $L_b=580\text{mm}$ , using the steel textile with  
 346 smaller cord spacing (S12). Despite the higher tensile strength, the denser textile had a weaker cord-to-  
 347 mortar interlocking, reducing, with respect to S4, both the maximum load per unit width ( $F_{\max}=170$ -  
 348  $196\text{kN/m}$ , Figures 9e-f and 12b, Table 2) and the efficiency of the system ( $\eta=23$ - $27\%$ ). Failure occurred at  
 349 the textile-to-mortar interface. The peak slip was smaller (between  $0.83\text{mm}$  and  $1.55\text{mm}$ ) than that measured  
 350 with S4 textile (Figures 9e-f and 12b, Table 2).

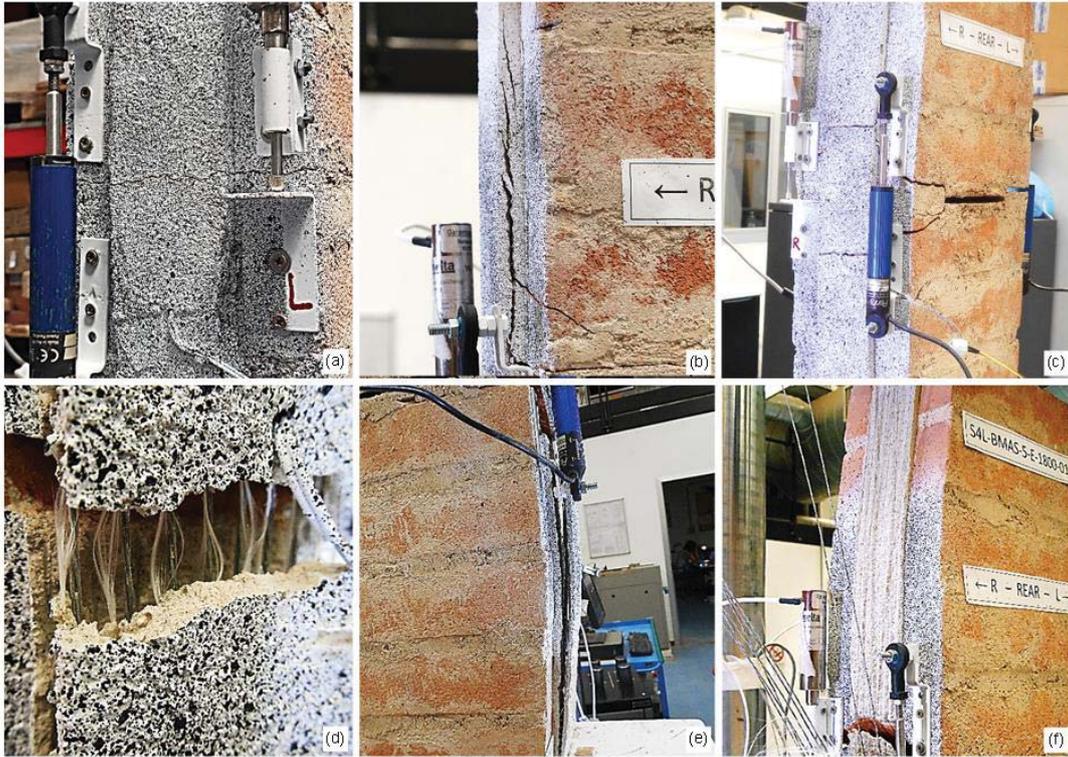
Figure 10. Progressive damage development during laboratory shear bond tests: initial horizontal crack in the central bed joint (a), longitudinal crack at the textile-to-matrix interface (b), transversal cracks of the mortar matrix (c), sliding of the steel cords (d), failure mode by detachment at the textile-to-matrix interface (e), with expulsion of the top layer of matrix in specimens with  $R=1800\text{mm}$  (f).

295 Failure always occurred by detachment at the textile-to-matrix interface (Figures 10e), with a sudden  
296 expulsion of the outer layer of mortar matrix in specimens with higher curvature ( $R=1800\text{mm}$ ) and shorter  
297 bond length ( $L_b=320\text{mm}$ , Figure 10f). In 20/22 cases, failure occurred on the more loaded side, while in the  
298 other 2/22 cases detachment took place where the load was lower. It should be considered that the two sides  
299 could never be identical, such that, in these two cases, the weaker reinforcement, despite subjected to a lower  
300 load, may have failed before the stronger (and more loaded) one.

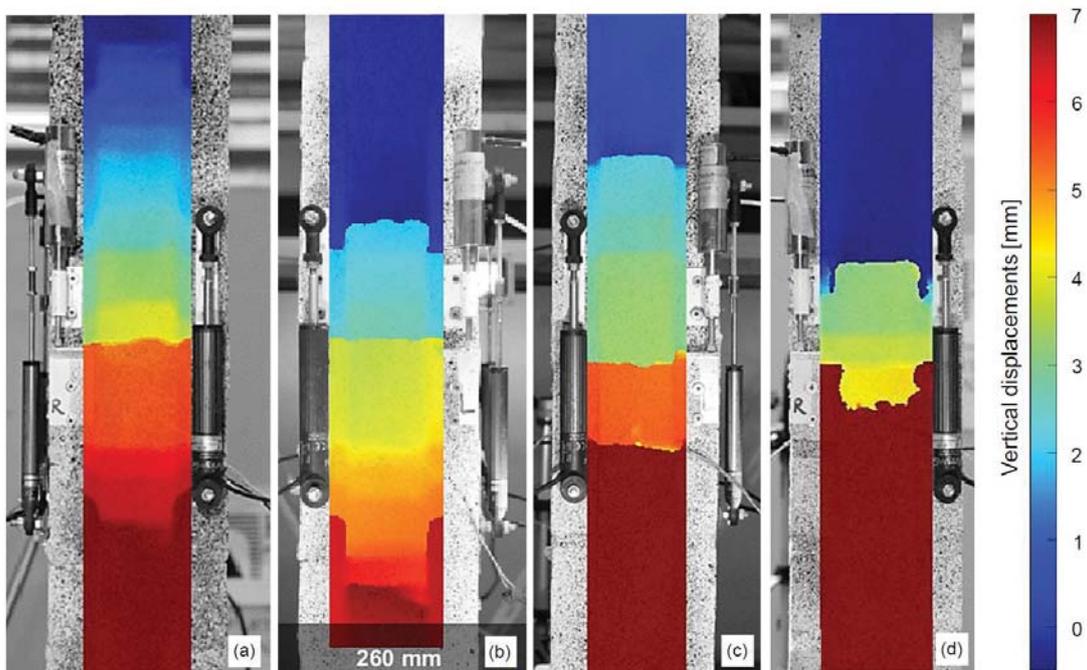
Figure 11. Field of vertical displacements recorded with the Digital Image Correlation on specimens with  $R$  infinite (plane surface, a),  $R=5000\text{mm}$  (b),  $R=2650\text{mm}$  (c), and  $R=1800\text{mm}$  (d).

289 Specimens with  $R=1800\text{mm}$  and  $R=2650\text{mm}$  exhibited less cracks than those with  $R$  infinite and  
290  $R=5000\text{mm}$ , as revealed by the smaller number of load drops in the response curves (Figure 8) and by the  
291 fields of vertical displacements measured with the Digital Image Correlation, in which cracks are clearly  
292 identifiable by the jumps of displacement (Figure 11). In specimens with higher curvature, the slip  
293 concentrated in one crack near the loaded end of the bonded area, and was associated to the sliding of the  
294 textile within the matrix along the entire reinforcement (Figure 11d).

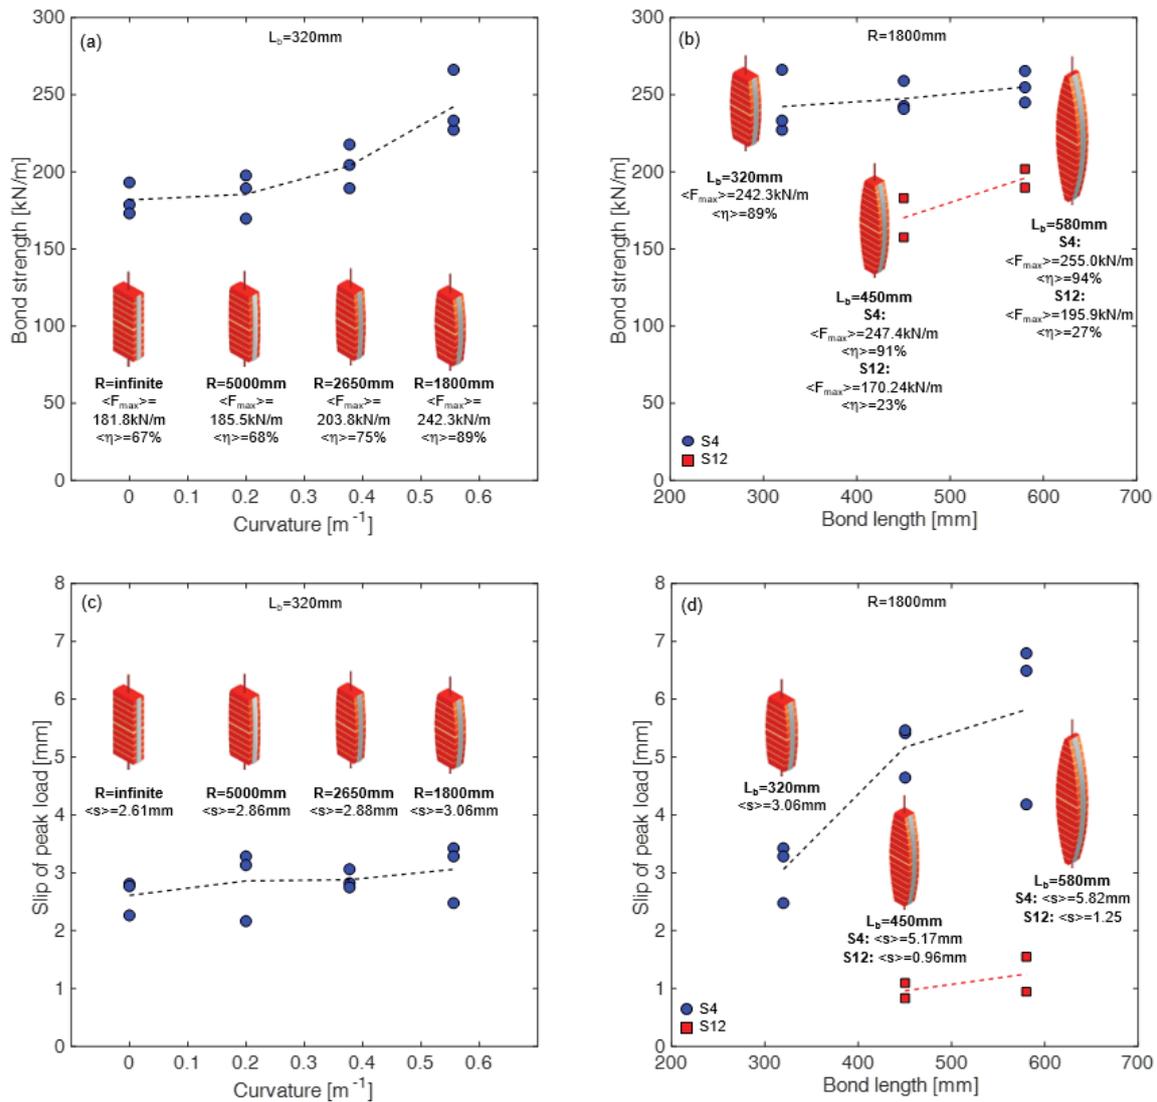
351  
 352 Figure 12. Bond strength (a,b) and peak slip (c,d) vs curvature (a,c) and bond length (b,d) for specimens with S4 textile and  
 353  $L_b=320\text{mm}$  (a,c) and for specimens with S4 and S12 textile and  $R=1800\text{mm}$  (b,d).

326 be considered that test results have a certain scatter and that only three specimens were tested for each  
327 configuration). The stress in the textile at failure ( $\sigma_{\max}$ ) ranged between  $2163\text{N/mm}^2$  and  $2884\text{N/mm}^2$  and the  
328 exploitation ratios ( $\eta=\sigma_{\max}/f_t$ ) between 67% and 89%. The gain in bond strength was also associated to an  
329 increase of the peak slip (s), i.e., the slip associated to  $F_{\max}$ , even if, in this case, the scatter is larger and the  
330 trend is weaker (Figure 12c).

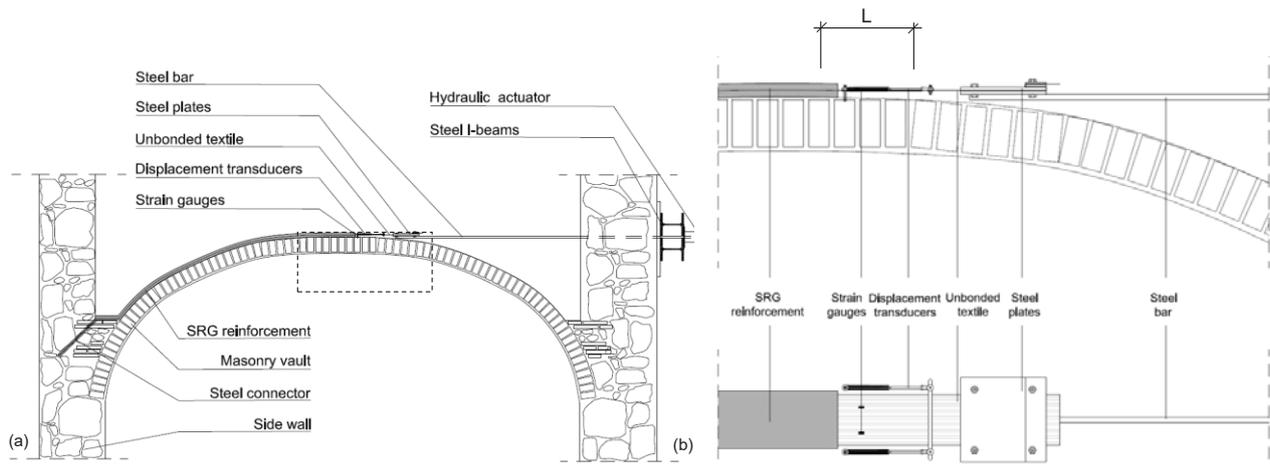
Figure 13. General view (a) and detail near the loaded (b) of the experimental setup for field tests.

363 The experimental setup (Figure 13) aimed at reproducing a loading condition similar to the one that the SRG  
364 reinforcement would experience if a crack developed at the extrados of the vault, due to the activation of a  
365 collapse mechanism characterized by the development of alternate (intrados/extrados) hinges. The actual  
366 stress state induced in the reinforcement may be, in fact, more complex due to the presence in the vault of a  
367 wider crack pattern and of a combination of bending and shear stresses.

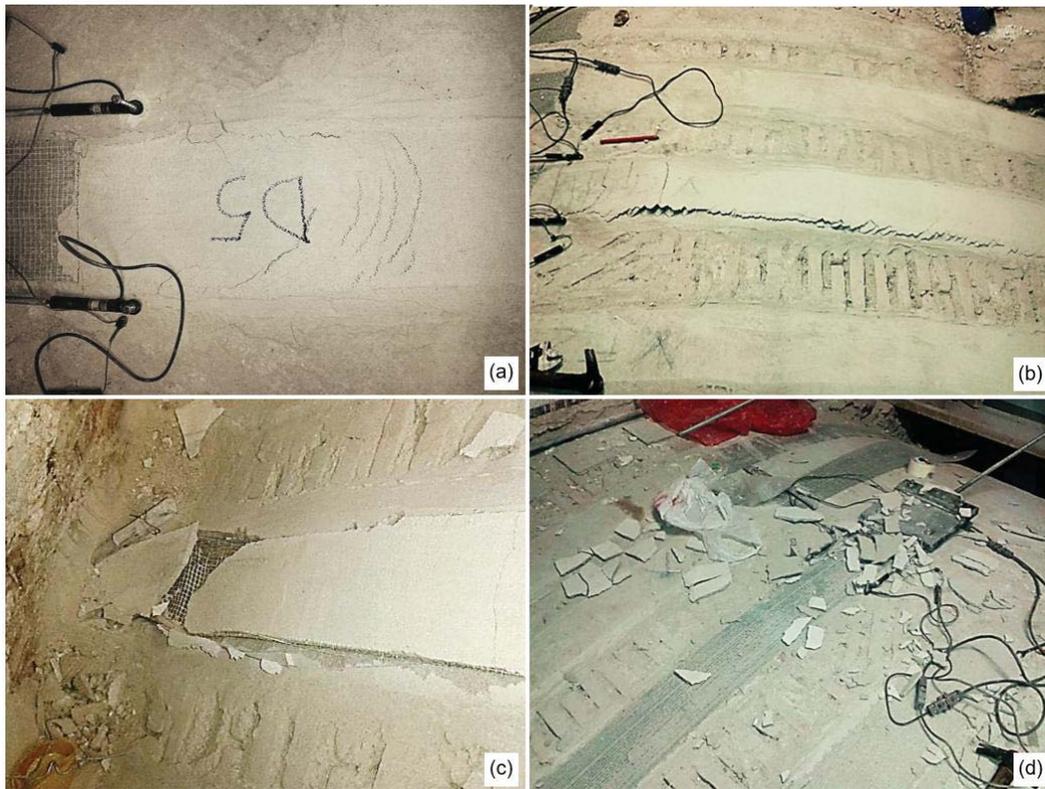
445 Figure 16. Progressive development of the crack pattern during field bond tests (for increasing applied load): first arched crack near  
 446 the loaded end (a), cracks at the SRG-to-substrate interface developing on the side on the reinforcement strip (b), debonding of the  
 447 entire SRG strip (c), and disintegration of the mortar matrix (d).

413 related to the test setup including possible misalignment of the loading system with the tangent to the vault at  
414 the crown, as well as potential lack of uniformly applied load along the textile width. Transversal cracks on  
415 the upper side of the SRG strip (Figure 16a) and longitudinal cracks on its side (Figure 16b) developed,  
416 starting from the loaded end of the reinforcement (i.e., its first bonded section). The crack pattern was  
417 influenced by the local properties of the substrate, such as depressions, imperfections, and small pre-existing  
418 cracks. Up to the end of Stage II, which could be identified at a load level of about 200-250kN/m, the bond  
419 behaviour of the SRG reinforcements applied to the vault was similar to that observed in laboratory tests on  
420 small-scale specimens, despite the different setups and specific properties of the substrate. Finally, in Stage

421 III, the debonding mechanism was activated at the textile-to-matrix interface and progressively moved from  
422 the crown to the abutment (Figure 16c). As in the laboratory, at the end of the test, the entire outer layer of  
423 the matrix, from the loaded end of the SRG strip to the connector, was spalled (Figure 16d). No cracks in the  
424 masonry wall or slippage of the steel connectors were detected (Figure 16c).
