Computer vision-based dynamic identification of a reinforced concrete elevated water tank

Abstract

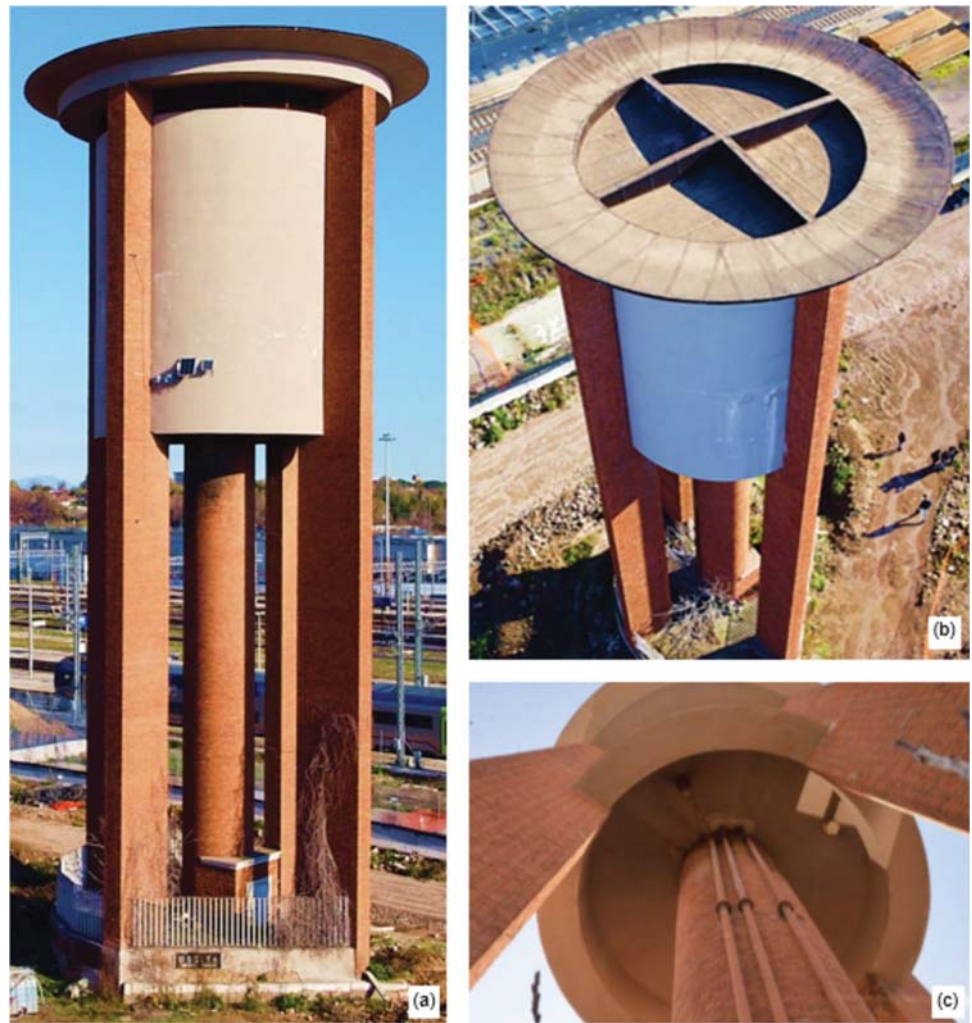
Fig. 1 Lateral (a), top (b) and bottom (c) view pictures of Tiburtina elevated water tank

As the drone camera was unable to tilt upwards by more than 20 degrees and due to the narrow space between the columns supporting the tank, the aerial survey was accompanied by a terrestrial survey, focussing on the bottom part of the tank. The terrestrial survey was carried

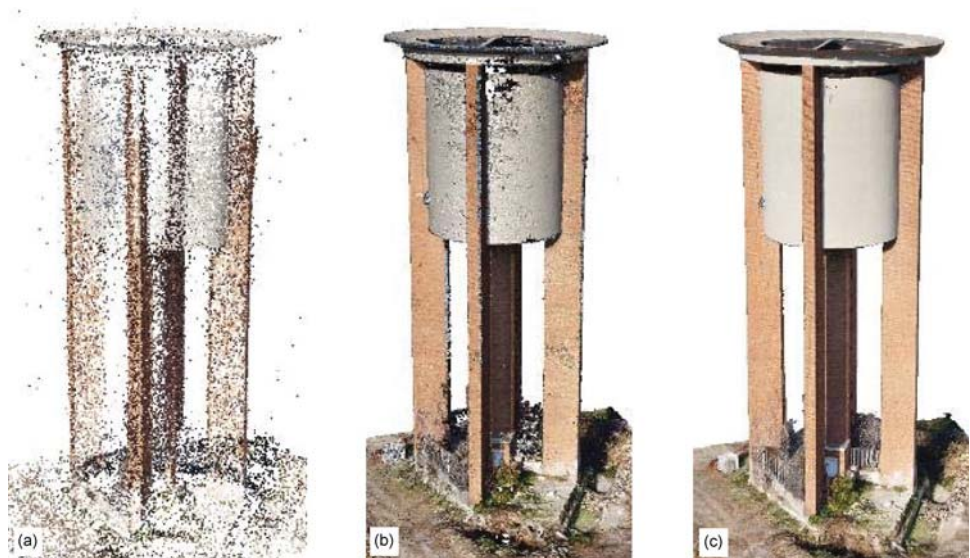
Fig. 3 Photogrammetric model of Tiburtina elevated water tank: sparse (a) and dense (b) point clouds, and 3D textured model (c)

Frames were processed in Agisoft Metashape Professional® [38]. A sparse point-cloud of approximately 217.000 points (Fig. 3a) was obtained first, and then a dense cloud of about 14 million points (Fig. 3b) and a 3D textured model (Fig. 3d) were derived. Twelve markers were placed on the columns and on the ground before surveying, which served as scale bars (known distances between predefined pairs of markers) allowing model scaling (conversion from pixel to millimetres).
